28 April 2017

Accident Investigation Board Norway  
Postboks 213  
2001 Lillestrøm  
Norway  
Phone: + 47 63 89 63 00  
Fax: + 47 63 89 63 01  
<http://www.aibn.no>  
E-mail: [post@aibn.no](mailto:post@aibn.no)

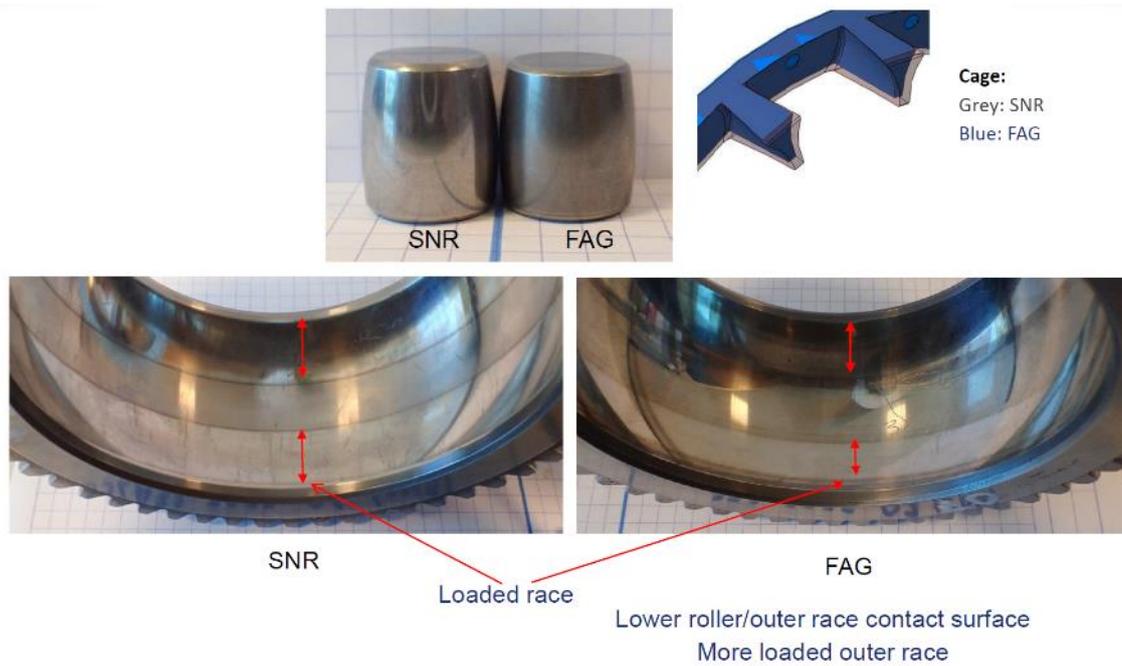
Figure 9: Differences between SNR and FAG bearings and contact pattern on outer race. Source: Airbus Helicopters

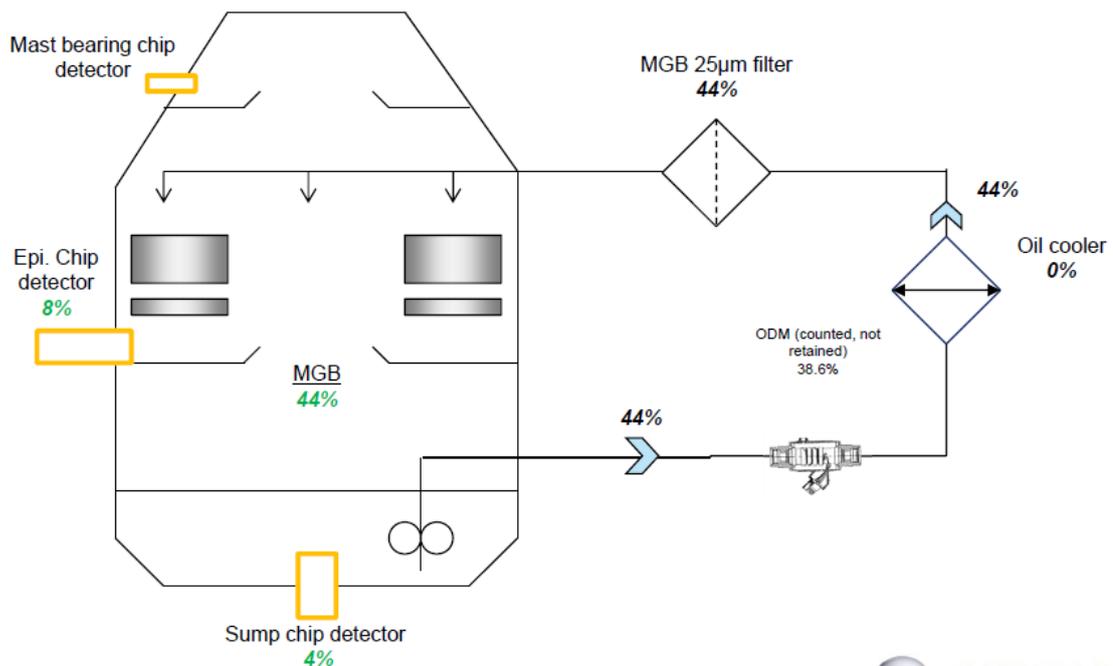
Figure 12: The test set-up and the detection rate of chip detectors (%: Particle quantity) presented following the G-REDL MGB spalling test program. Source: Airbus Helicopters

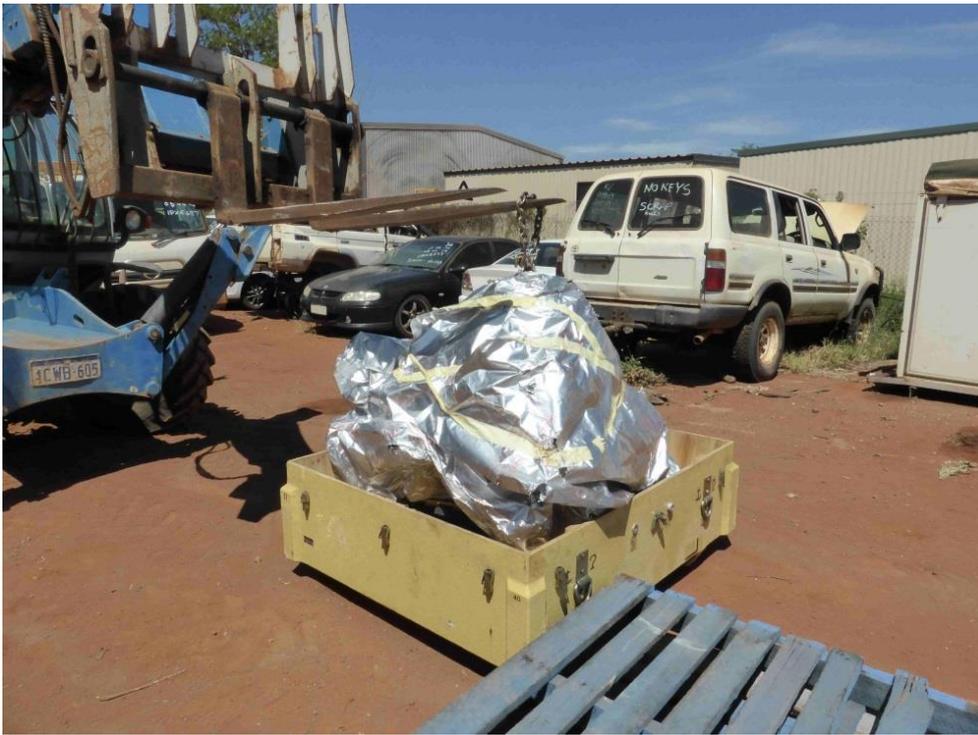
Figure 13: MGB in transport container after the transport accident. Photo: Airbus Helicopters

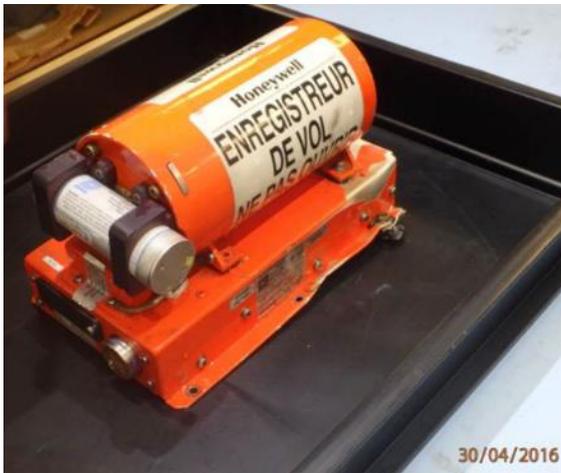
Figure 14: CVFDR from LN-OJF as received at the AAIB. Photo: AIBN

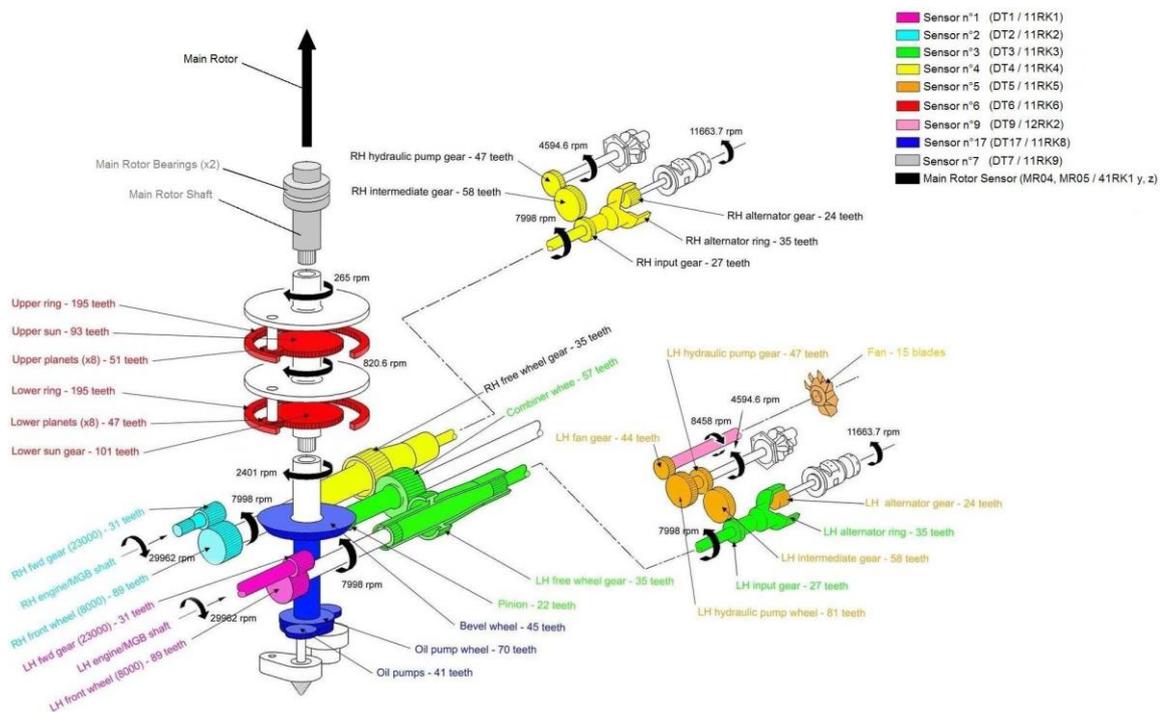
Figure 17: Drive train of the EC 225 LP MARMST™ (MGB). Source: Airbus Helicopters

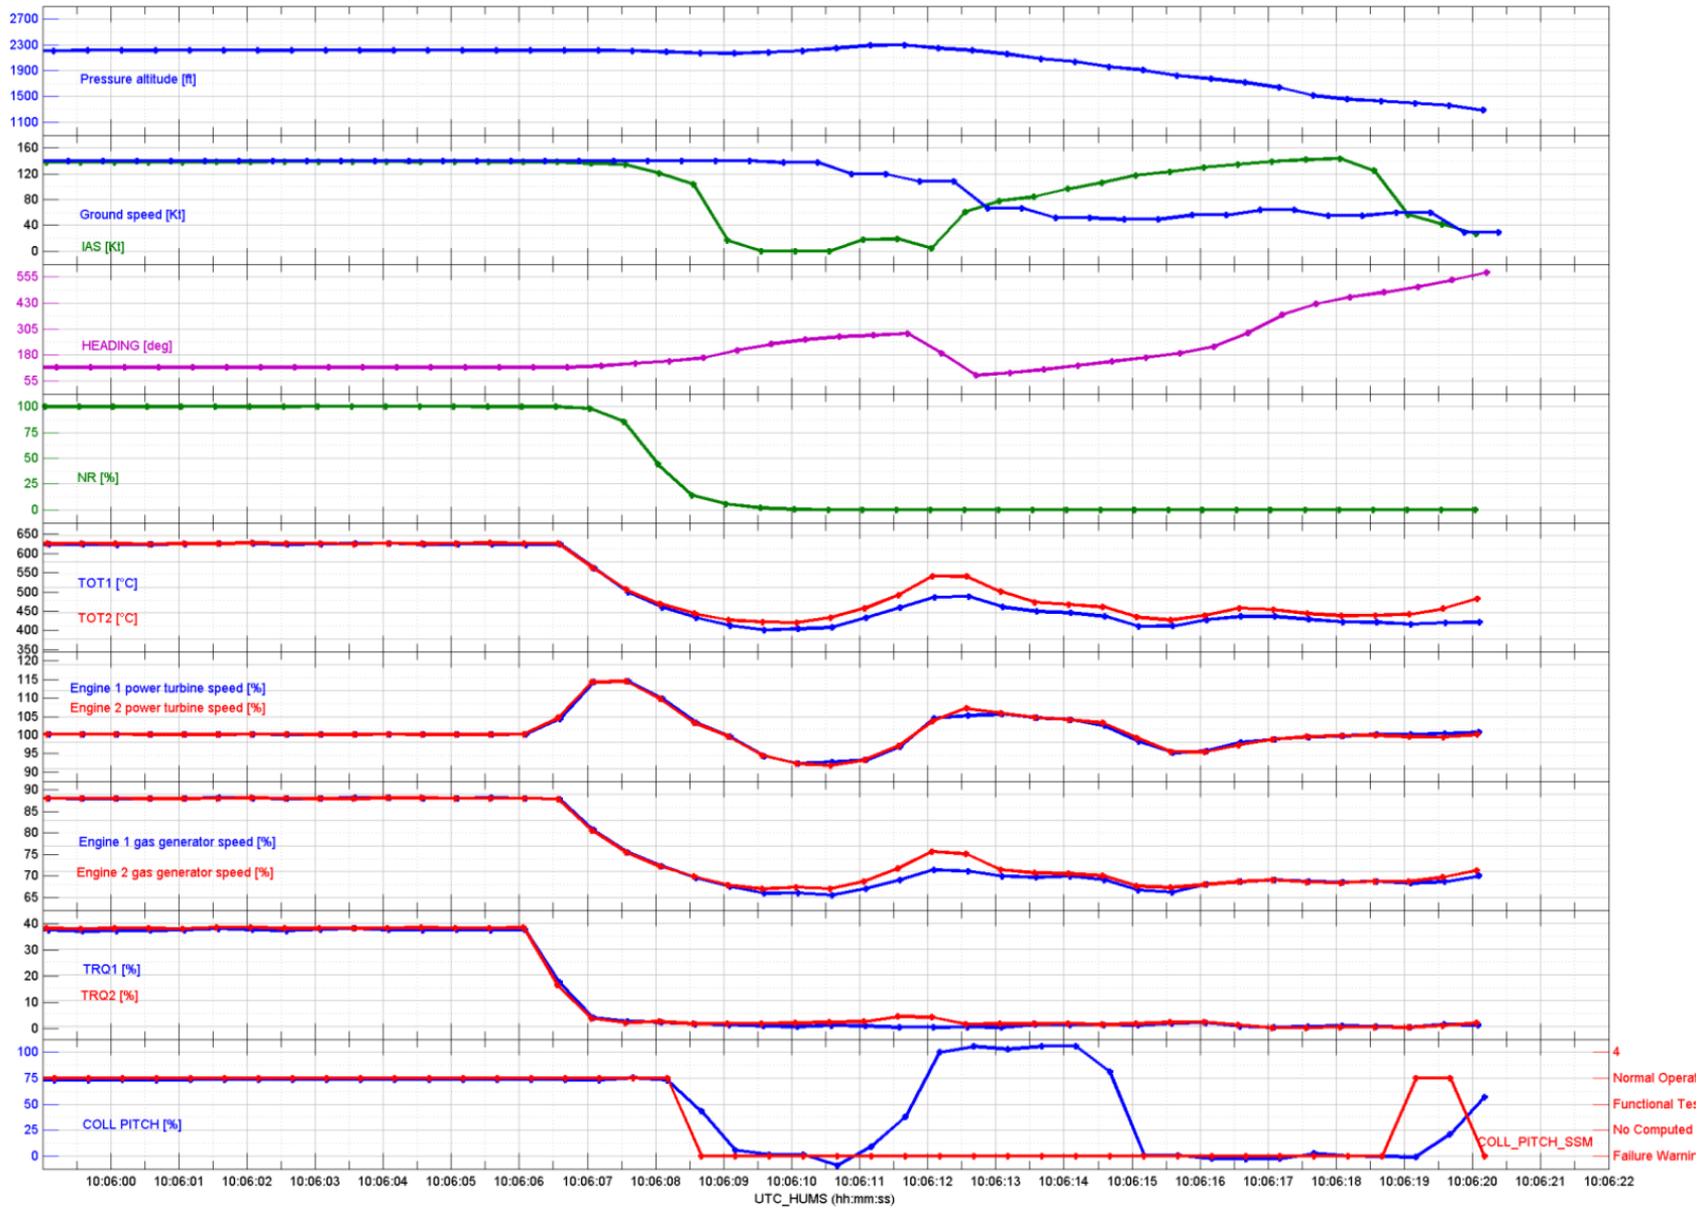
Figure 18: Recorded parameters from the PCMCIA card. T0 is defined as 10:06:06. Note: Time is UTC minus approximately 11 min. Source: BEA

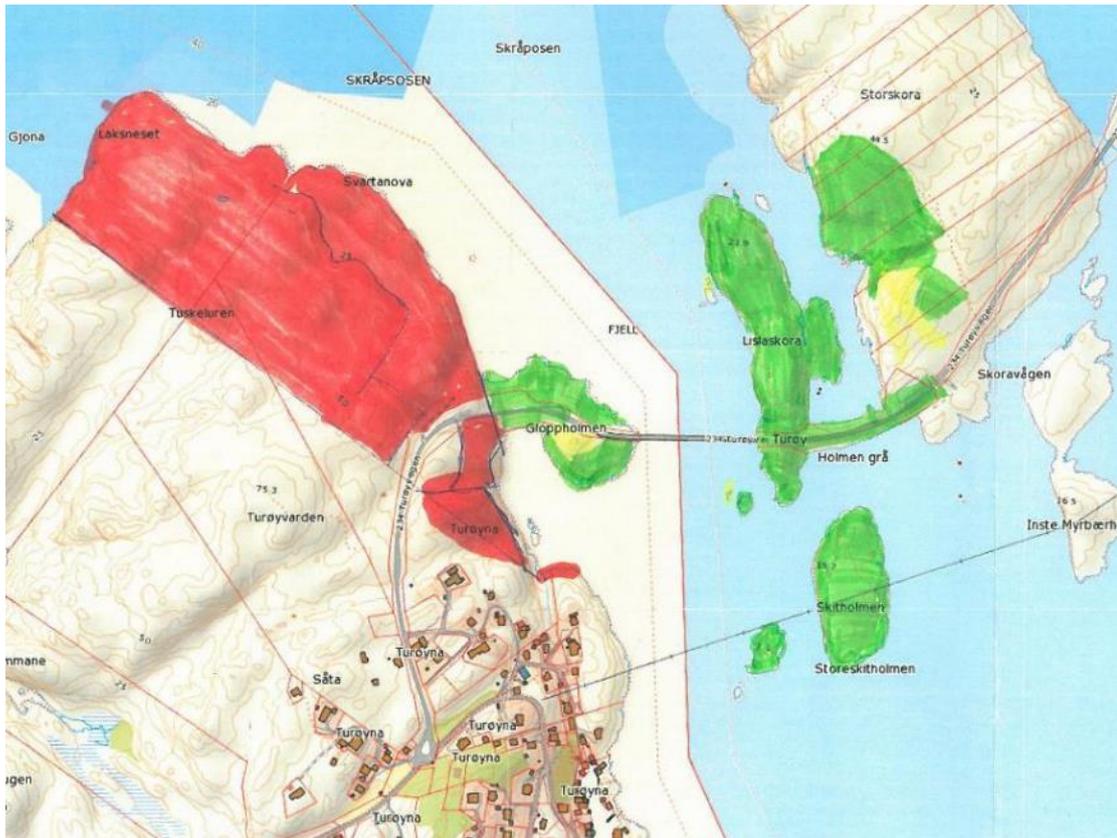
Figure 19: A preliminary sketch of the initial land search area (green) and an additional area (red).  
Source: The Norwegian Mapping Authority and AIBN

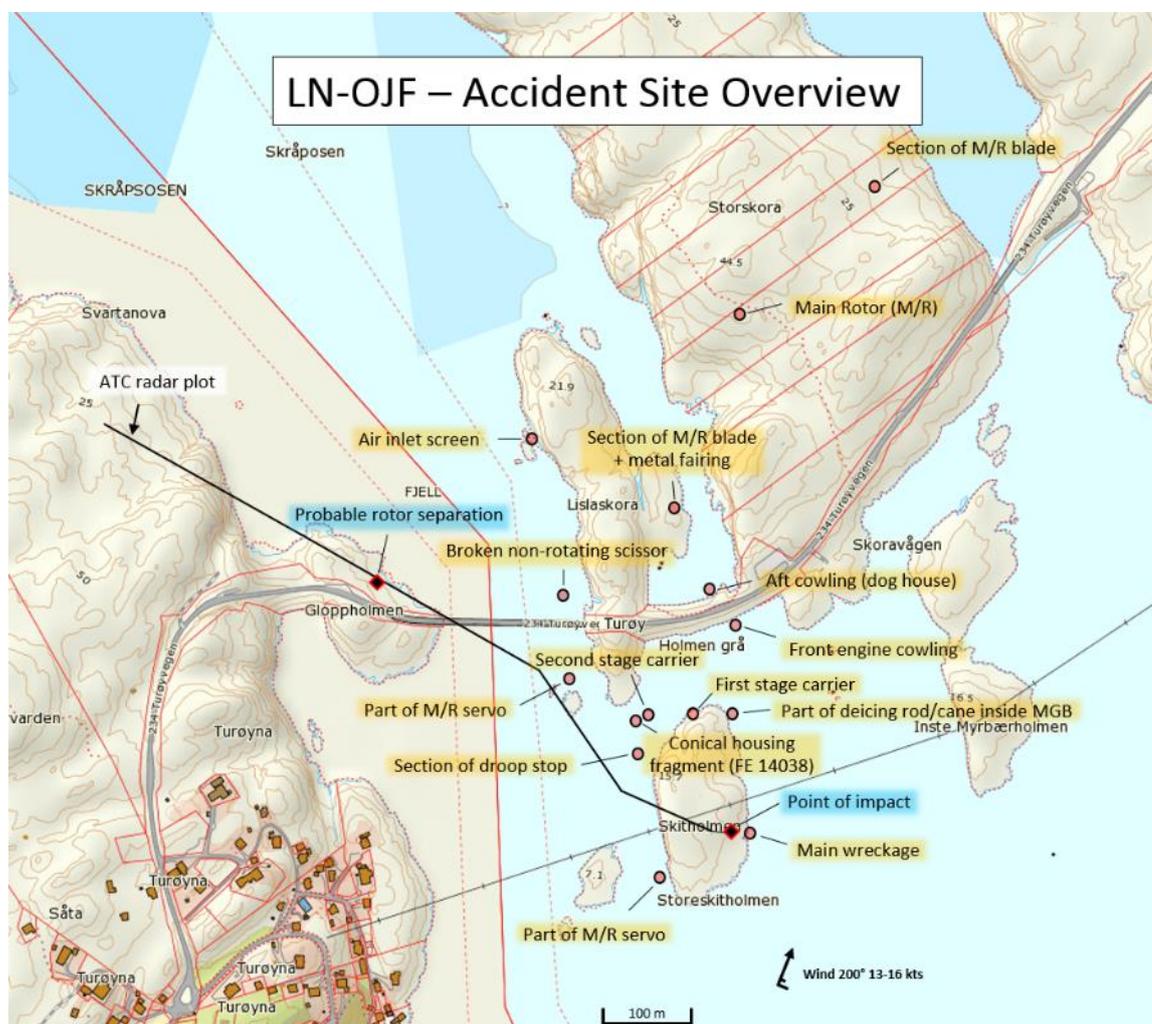
Figure 21: This map does not include all findings. However, it illustrates the location of larger parts or parts where the location can give useful information. The AIBN finds reasons to believe that the aft MGB cowling did fall down on the shown position, but was rather moved there by people at an early stage. Source: The Norwegian Mapping Authority and AIBN

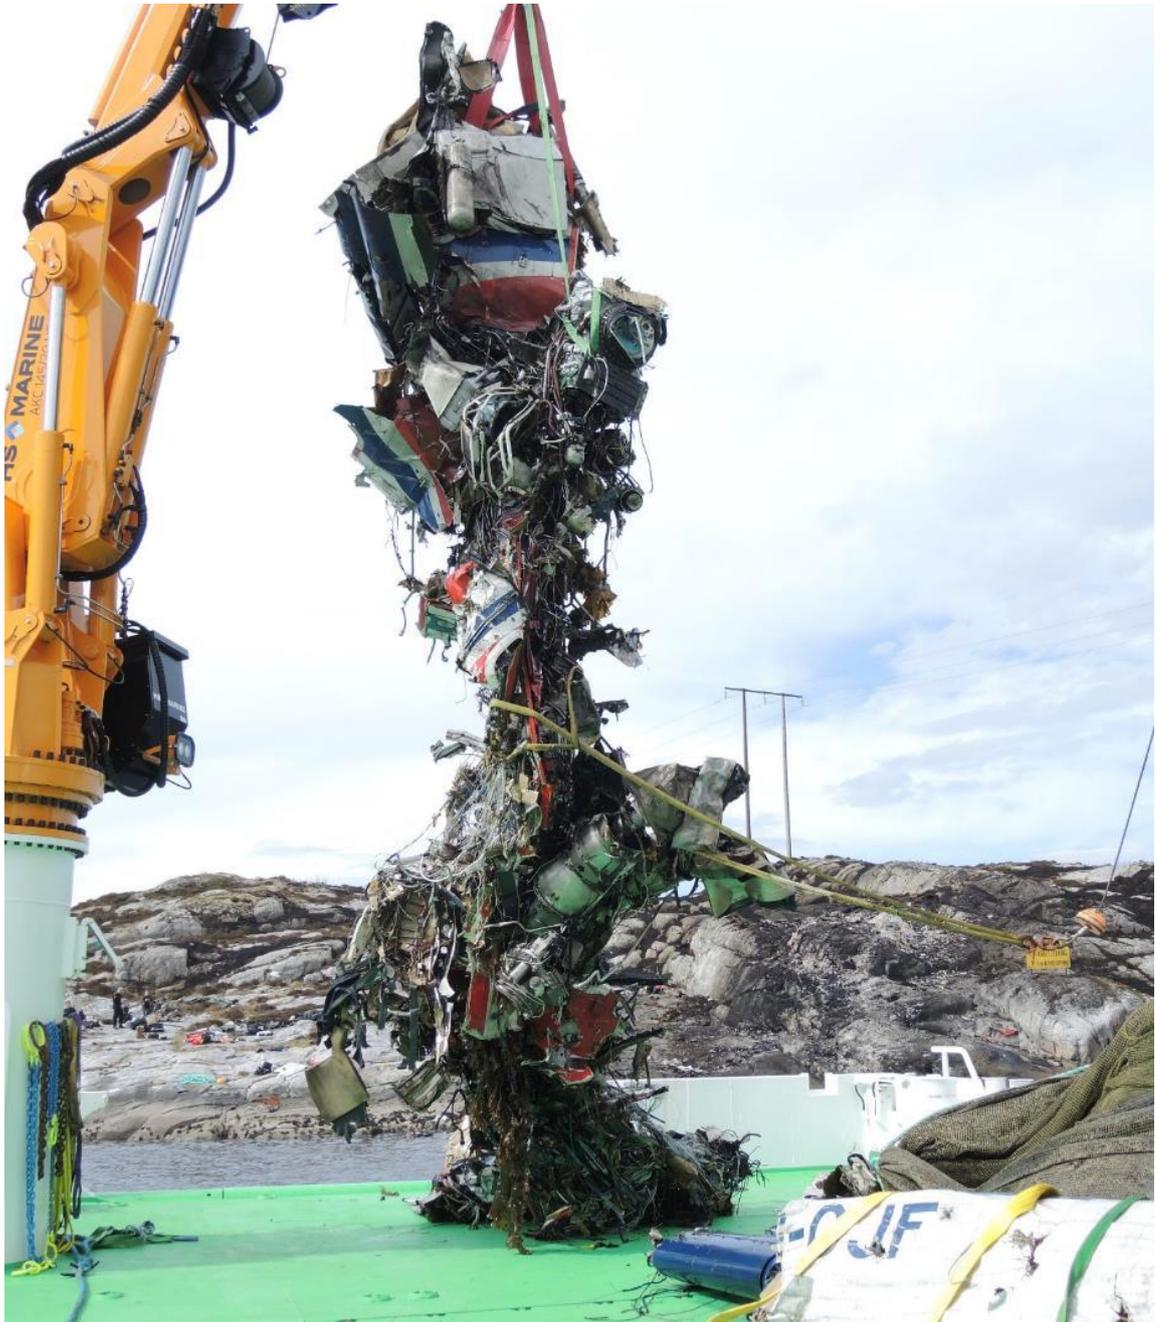
Figure 22: The main wreckage during recovery. The tail boom seen at the lower right had already been recovered. Photo: AIBN

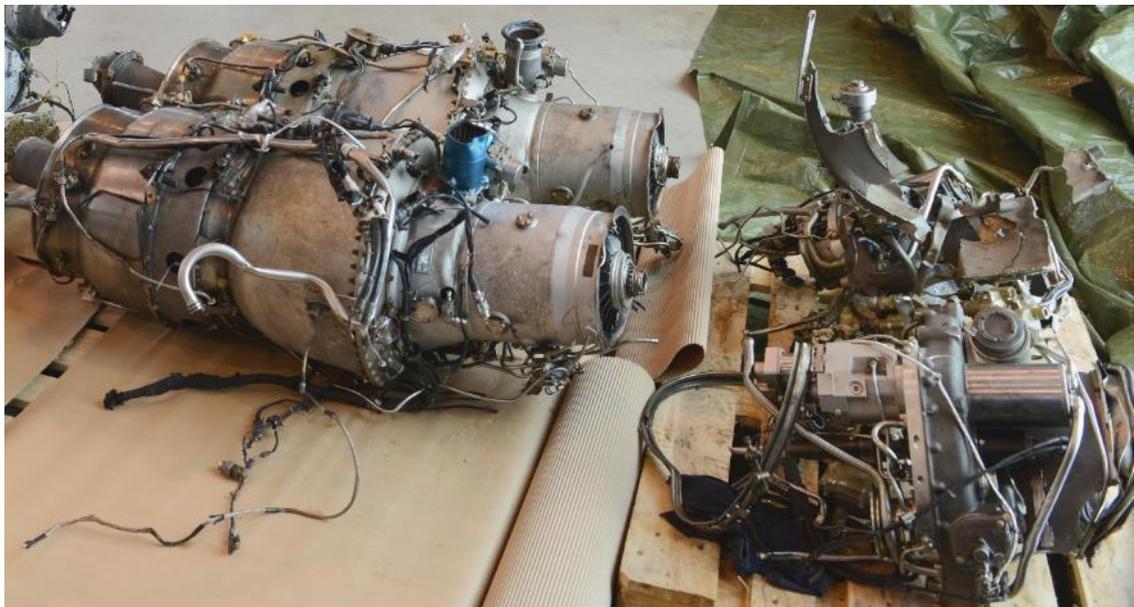
Figure 23: The engines at the AIBN hangar. They had similar damages to a large extent. Both intake sections (Module M01) which had separated from the front part of the engines can be seen to the right of the photo. Photo: AIBN

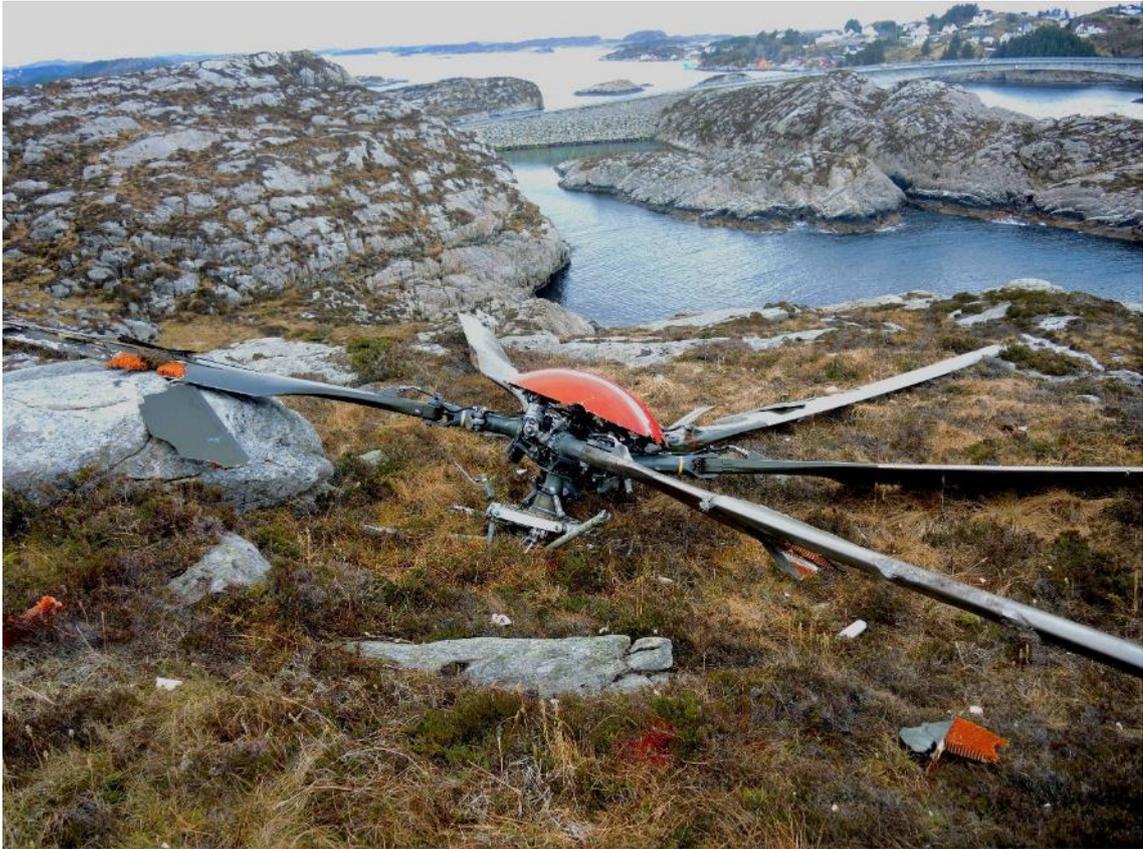
Figure 24: The main rotor and rear suspension bars as found at the island Storskora.  
Photo: AIBN

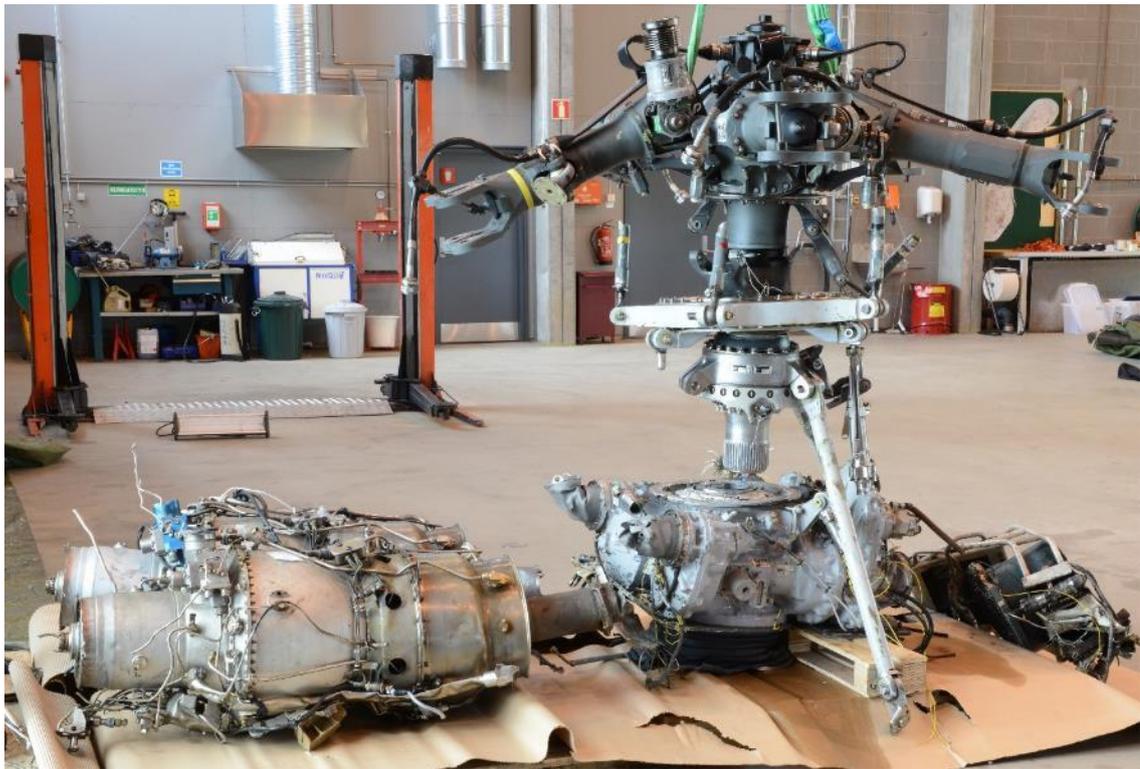
*Figure 25: Engines, substantial parts of the MGB, two suspension bars and main rotor head assembled at the AIBN premises. Photo: AIBN*

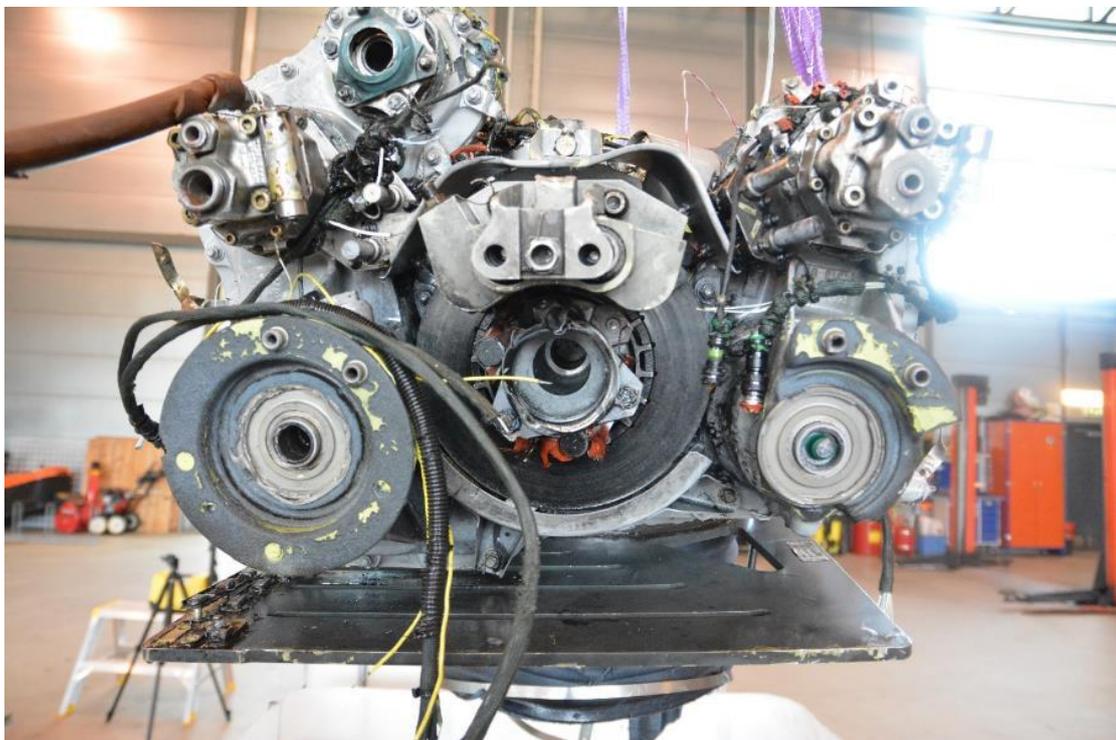
Figure 26: L/H and R/H accessory modules seen from behind. The flexible mounting plate is seen attached to the MGB oil sump. Photo: AIBN

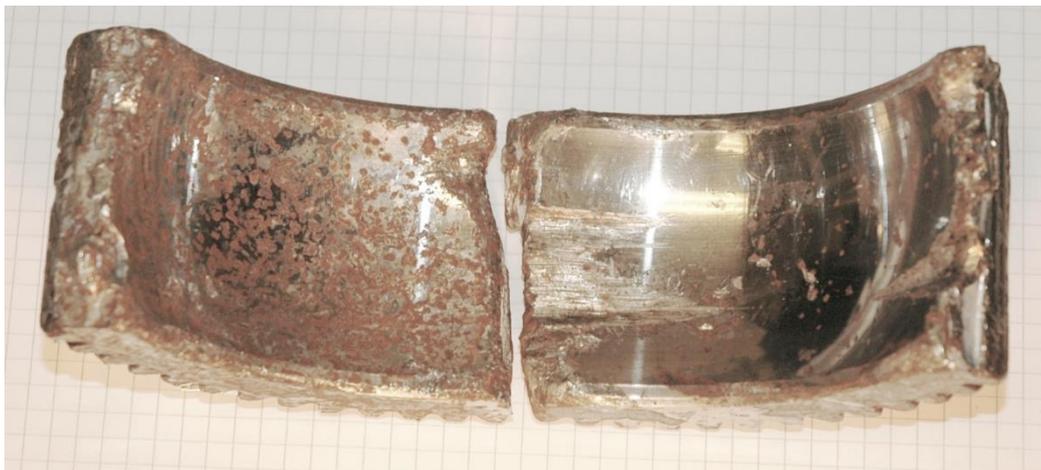
Figure 27: The two fractured gear segments. Appearance of wear marks on the right, while not on the left indicate separation while other parts still have been in motion. Photo: AIBN/NDL

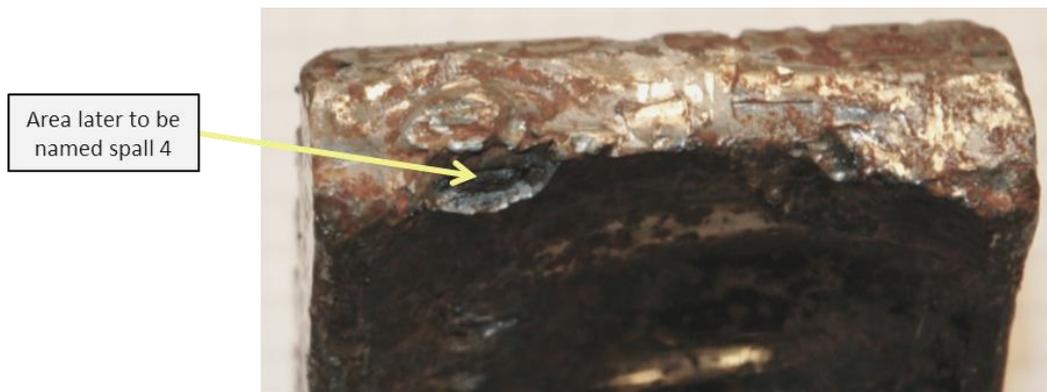
Figure 28: The fracture surface to the left in Figure 27, in general other surfaces appeared to be ductile overload, however, this surface indicated by the yellow arrow was of particular interest. Photo: AIBN/NDL

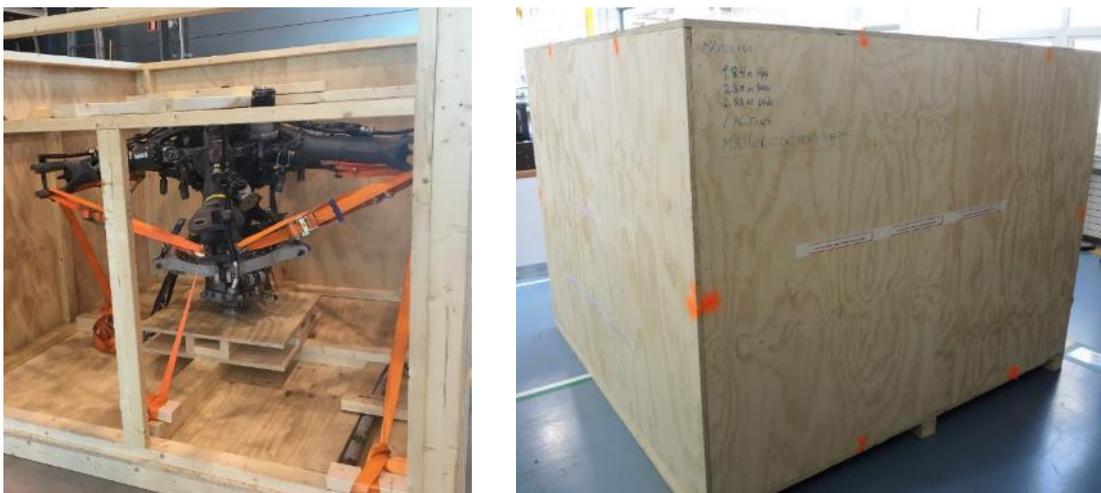
Figure 29: MRH, rotor mast and suspension bars packed for shipping (left photo) and as received at Airbus Helicopters (right photo). Photo: AIBN

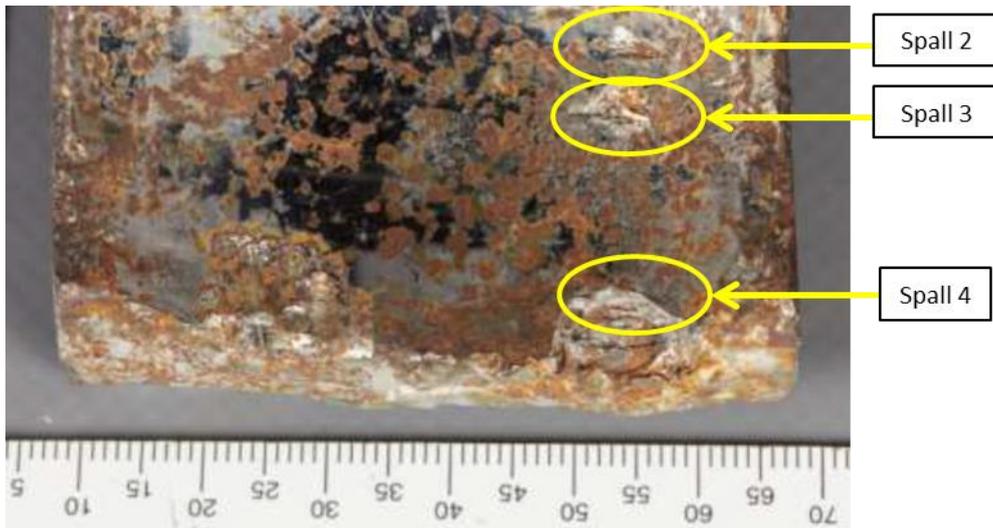
Figure 30: The fatigued surface as received at QinetiQ before cleaning. Along a line approximately 14 mm from the upper surface of the gear (right hand edge in photograph) some holes or spalls are observed, with the largest (named spall 4) located at the edge of the through-thickness fracture. Photo: AIBN/QinetiQ

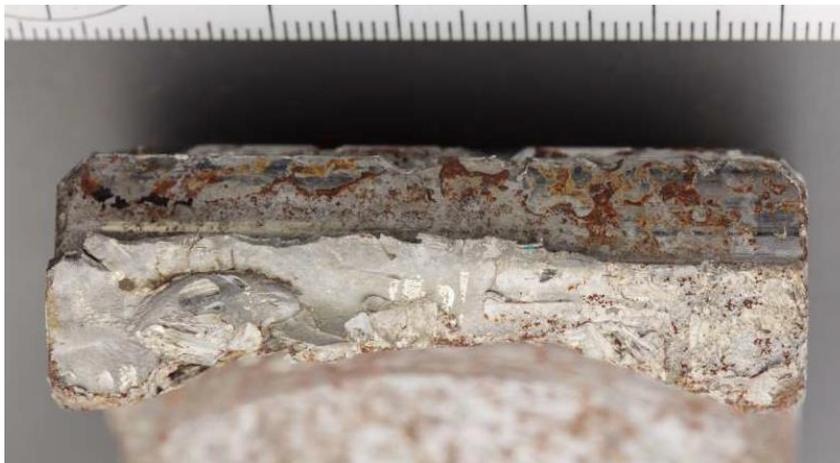
Figure 31: The cleaned through-thickness fracture surface. The cleaning was performed using a combination of acetate replica stripping and inhibited HCl solution with ultrasonic agitation. Macro marks (beach marks) are visible towards the upper edge of the gear (left hand side in photograph). Photo: AIBN/QinetiQ

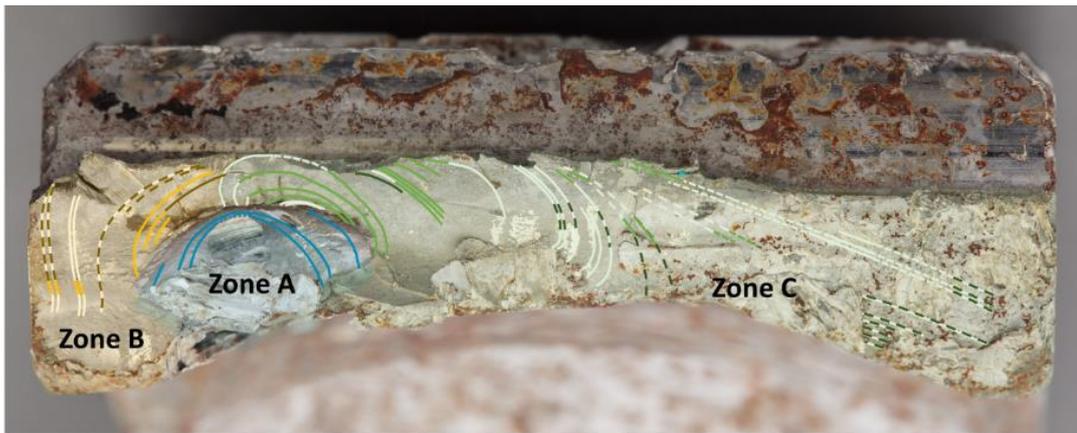
Figure 32: The fracture surface divided into three different zones. The macro marks /features observations are indicated: solid line – well defined, dashed line – less well defined. Photo: AIBN/QinetiQ and Airbus Helicopters

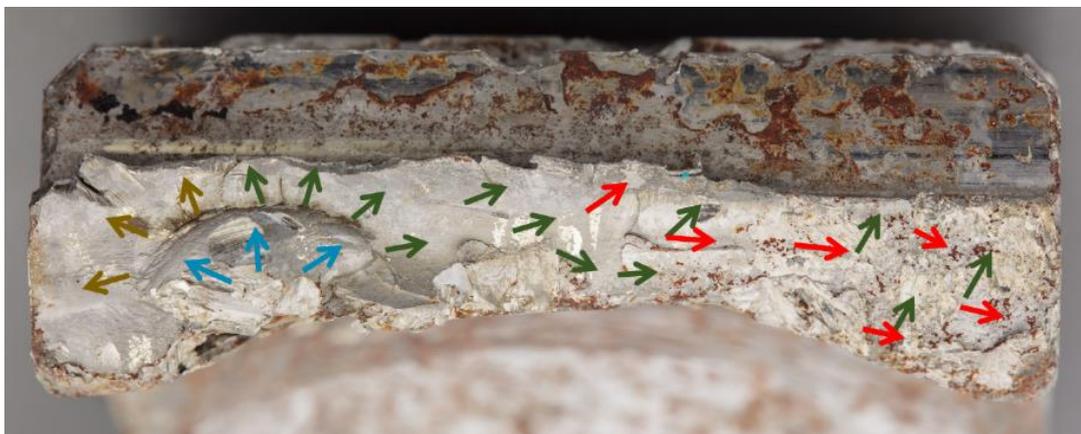
Figure 33: Crack propagation directions concluded from macro mark orientations in zones A (blue), B (brown) and C (green). Propagation in zone C concluded from striation and micro crack orientations is shown by the red arrows. Photo: AIBN/QinetiQ

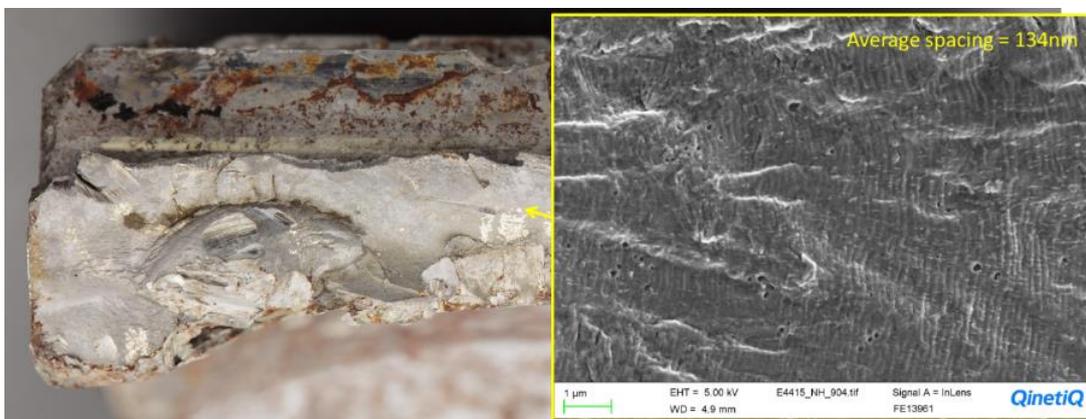
Figure 34: Fatigue crack progression marks – striations. Average spacing between the striations in this area are 134 nm. Photo: AIBN/QinetiQ

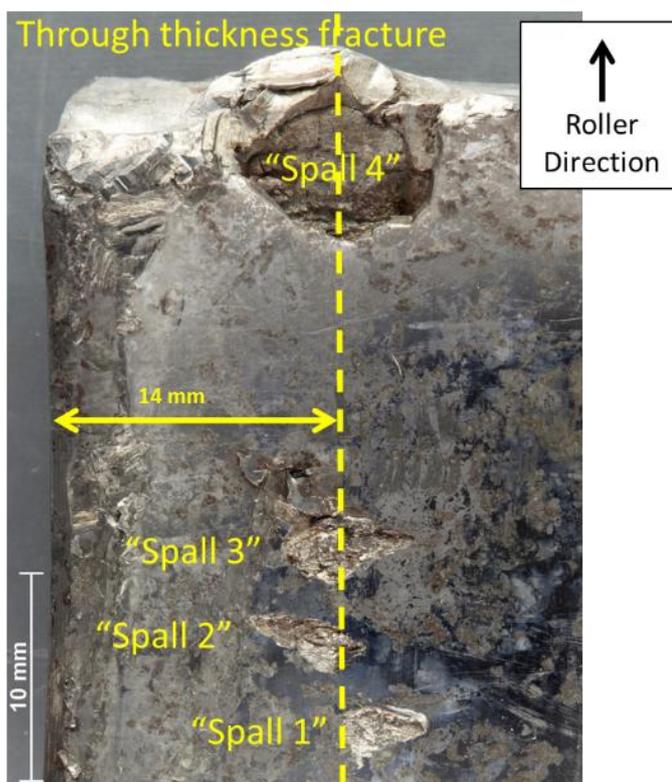
Figure 35: Showing spall one, two, three and four together with the max Hertzian stress line of 14 mm. Photo: AIBN/QinetiQ

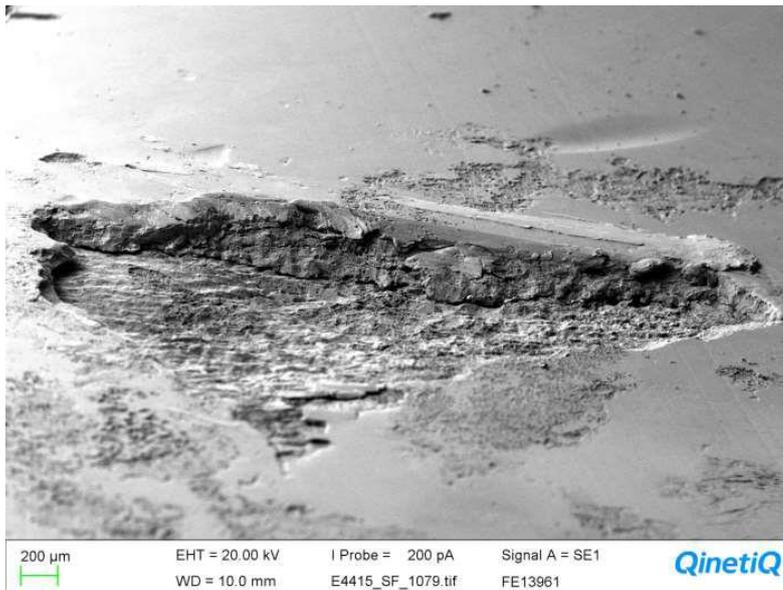
Figure 36: Spall one looking in the direction of spall two (in roller direction). A crack continuing under the surface is observed. Photo: AIBN/QinetiQ

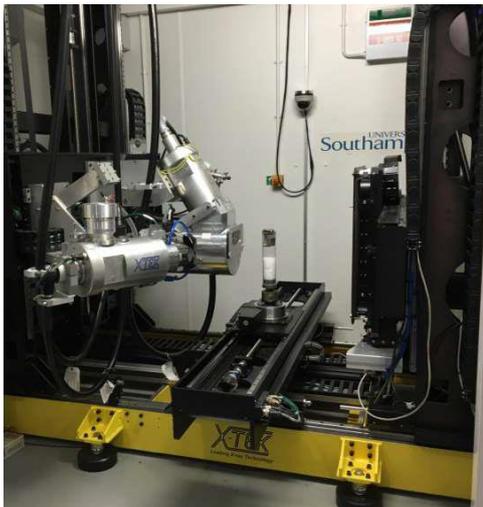
Figure 37: The x-ray tomography set up. The part to be scanned is in the tube in the centre of the figure. Photo: AIBN

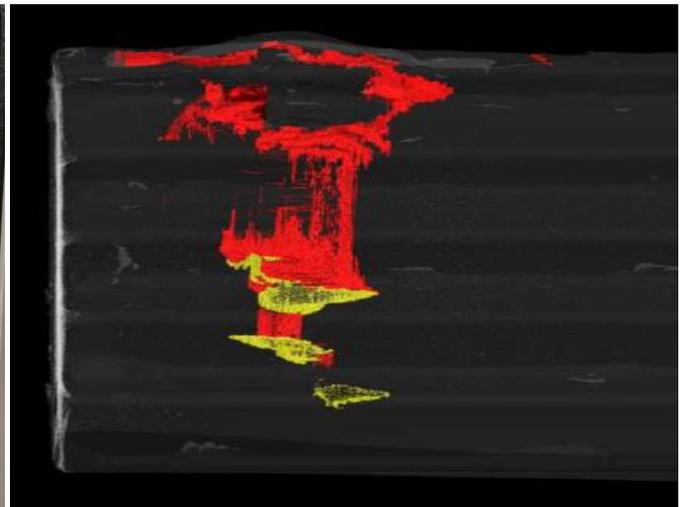
Figure 38: CT-scan of the specimen in Figure 35. The yellow areas are spall one, two and three. The red area indicates a sub-surface crack. Photo: Threshold CT-scan image from AIBN/Southampton University

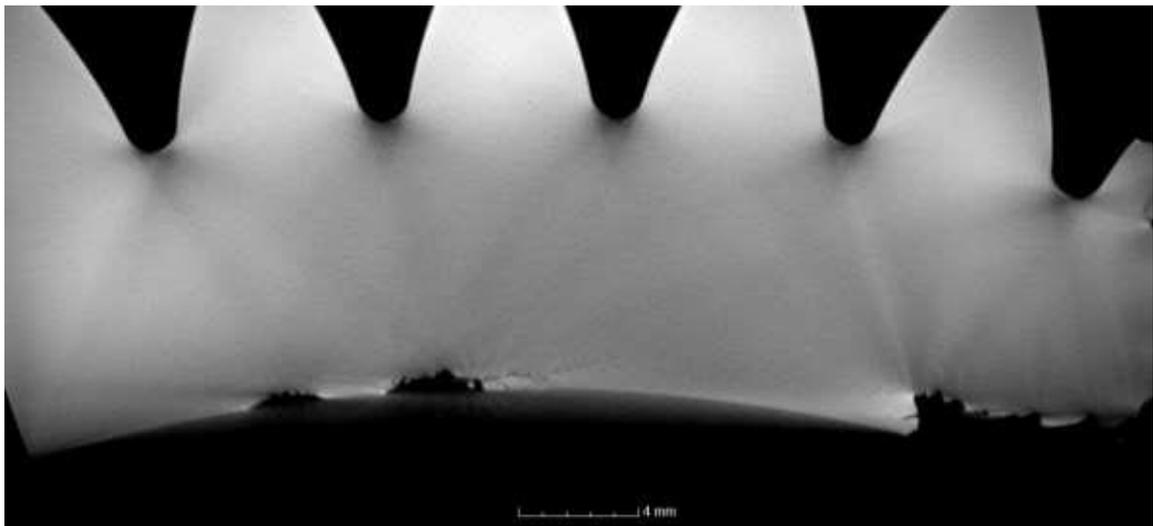
Figure 39: Longitudinal slice from CT-scan showing several cracks below the surface of the outer race. One crack runs below the surface between spalls (areas of surface damage). Photo: CT-scan from AIBN/Southampton University

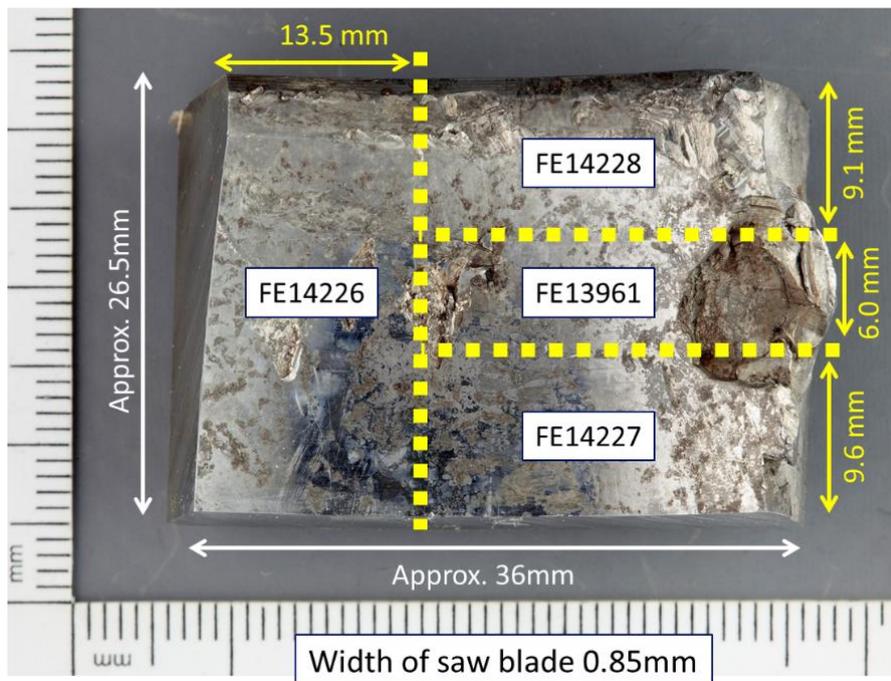
Figure 40: Cutting lay out based on CT-scan results (see Figure 37). FE13961 contains spall three and four, FE14226 contains spall one and two. Photo: AIBN/QinetiQ

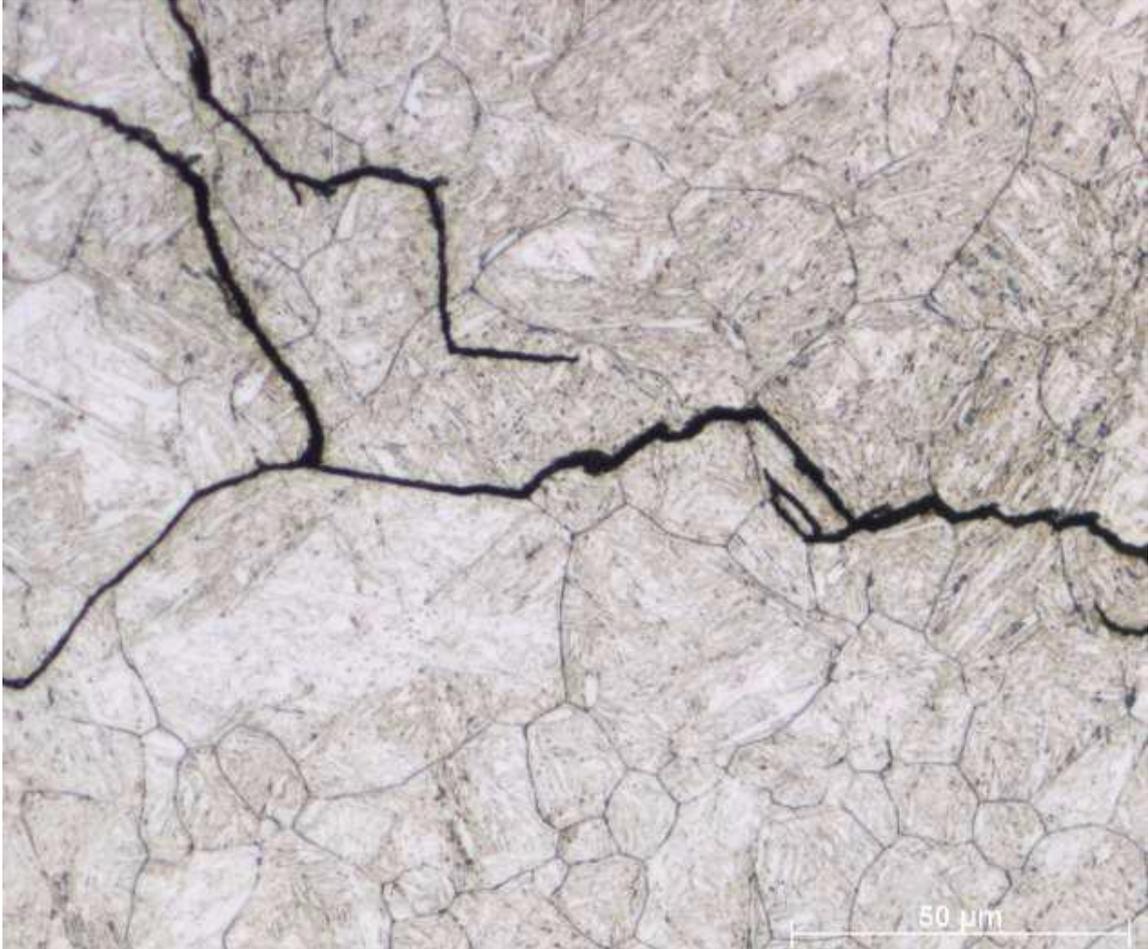
*Figure 41: The sub-surface crack propagation is both trans- and inter-granular. Polished surface etched with saturated Picric acid solution (with HCl). Roller direction to the left.  
Photo: AIBN/QinetiQ*

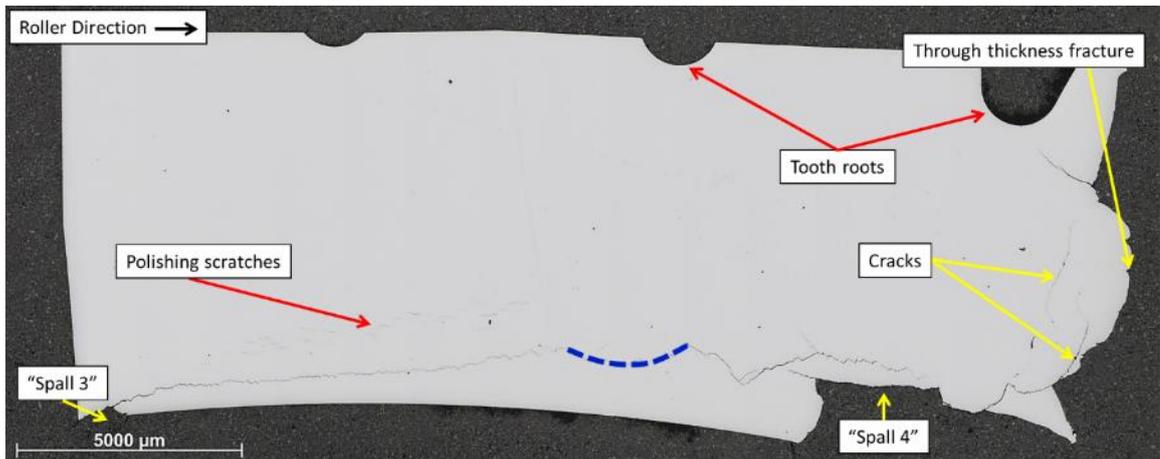
Figure 42: Sample FE13961 (see Figure 40). The microsection is 16.8 mm from upper edge. Cracks deviating towards the race surface stop and thus do not release particles. Photo: AIBN/QinetiQ

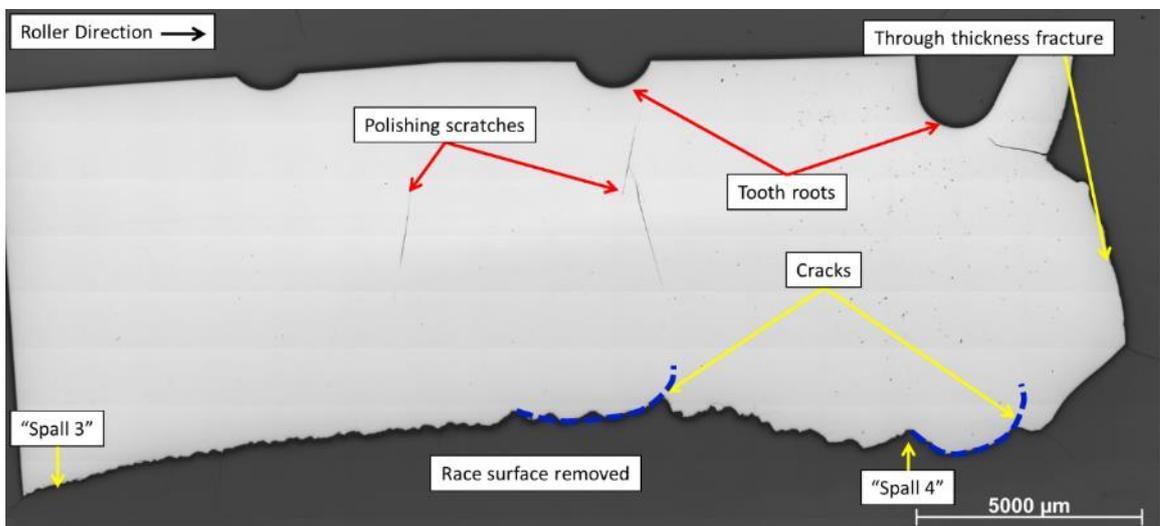
Figure 43: Sample FE13961 (see Figure 40). The microsection is further polished to 15 mm from upper edge. The microsection shows deviations towards the gear teeth roots. Photo: AIBN/QinetiQ

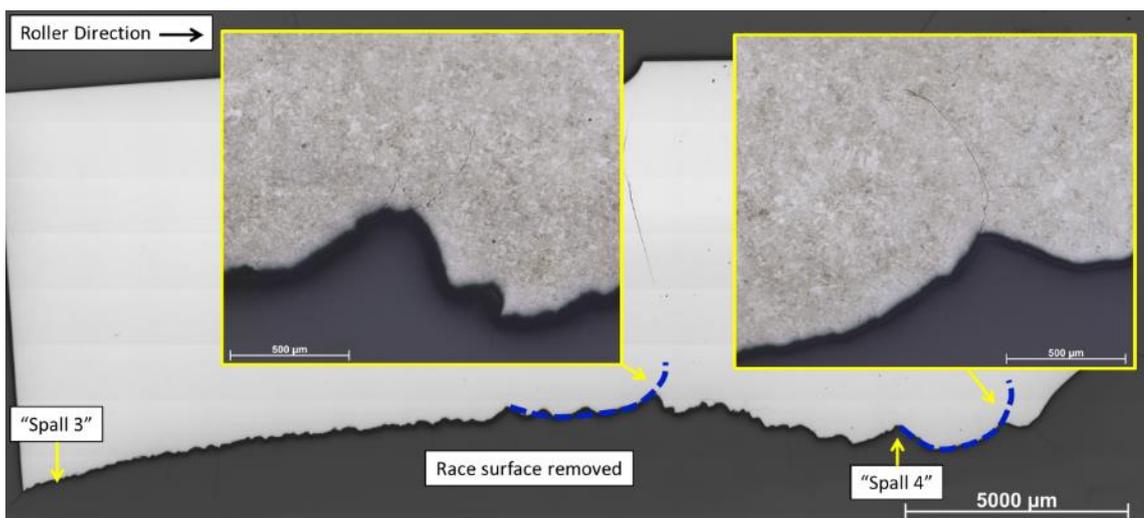
Figure 44: Sample FE13961 (see Figure 40). The microsection shows a close up of deviations towards the gear teeth roots. Photo: AIBN/QinetiQ
