28 April 2017

Accident Investigation Board Norway  
Postboks 213  
2001 Lillestrøm  
Norway  
Phone: + 47 63 89 63 00  
Fax: + 47 63 89 63 01  
<http://www.aibn.no>  
E-mail: [post@aibn.no](mailto:post@aibn.no)

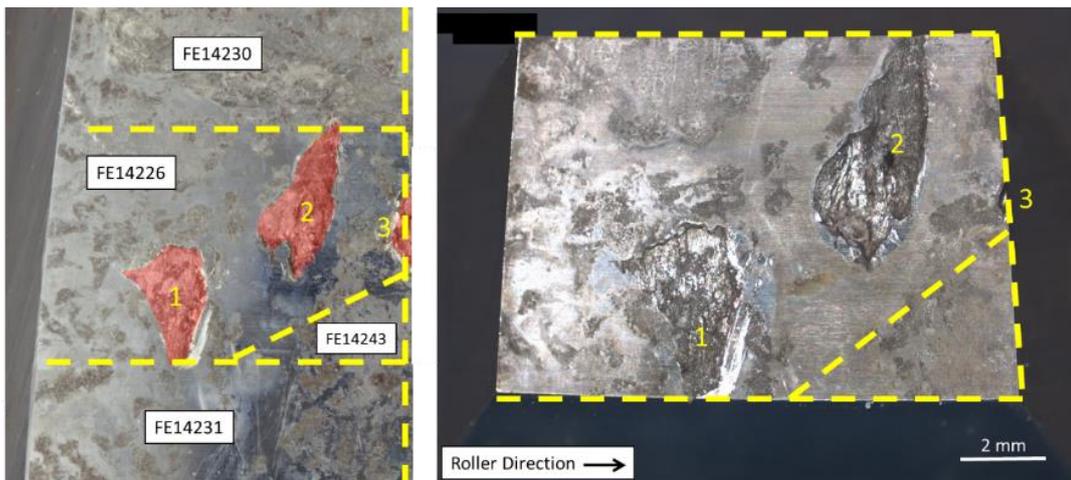
Figure 45: Figure showing cutting for examining spall one and two and the area around and between the spall one, two and three. Photo: AIBN/QinetiQ

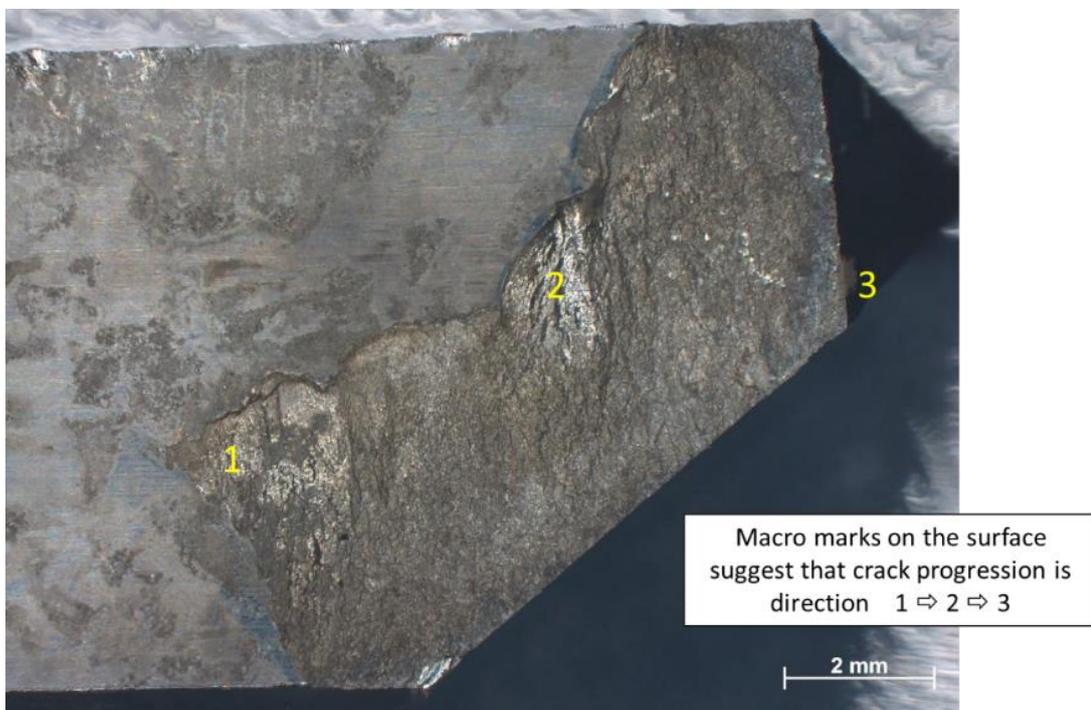
Figure 46: Figure showing the area between spall one, two and three after removal of the race surface. Photo: AIBN/QinetiQ

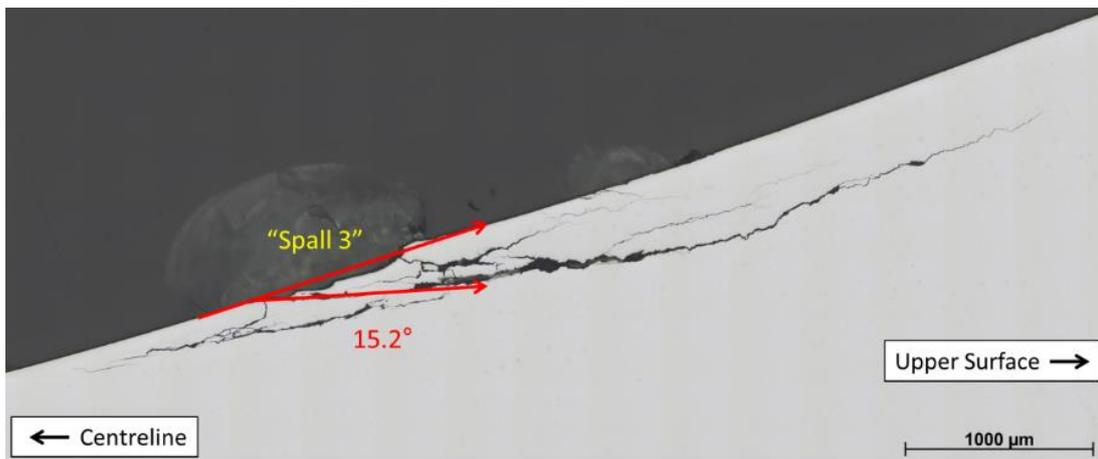
Figure 47: A transverse microsection of spall 3 with the angle crack propagation of 15.2°. Photo: AIBN/QinetiQ

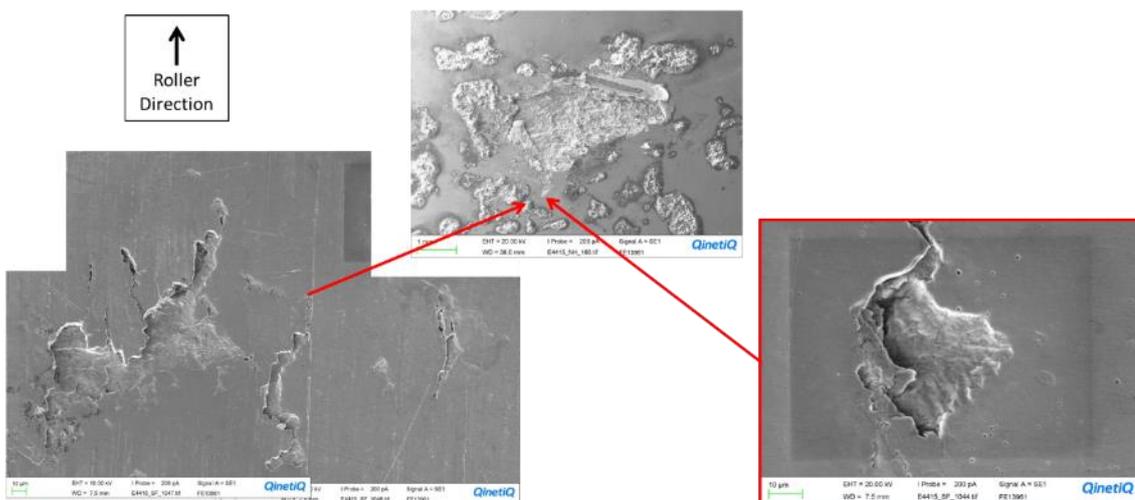
Figure 48: The micro-pits in the area in front of spall one and the pit (lower right) that appears to grow into the area of spall one (upper centre). Photo: AIBN/QinetiQ

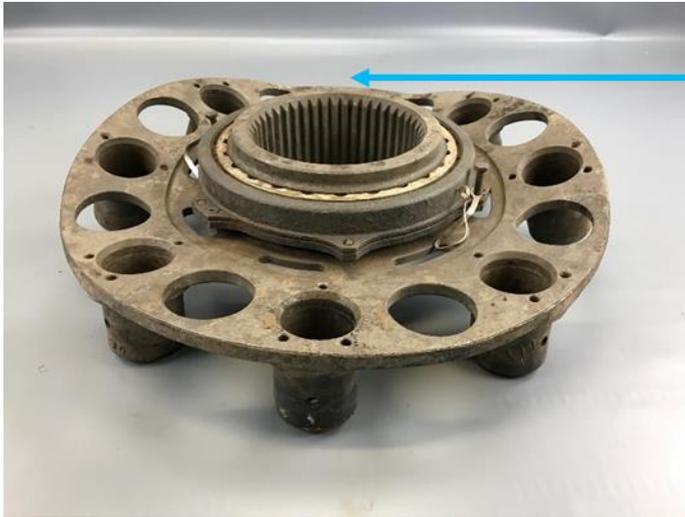
Figure 49: The second stage planet carrier found in February 2017 shown after cleaning. The lower mast bearing is shown on top of the carrier. Photo: AIBN/QinetiQ

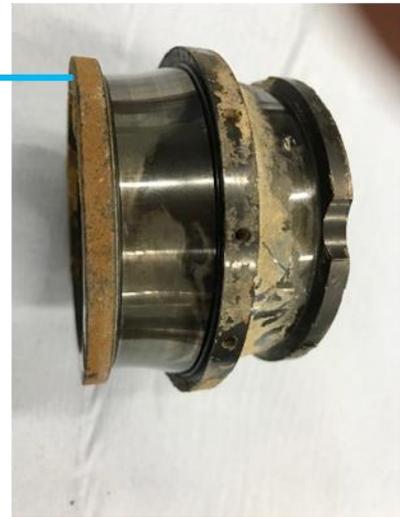
Figure 50: The inner race of the fractured planet gear after cleaning of the upper race (left in photo). Position on the carrier is given by the arrow. Photo: AIBN/QinetiQ

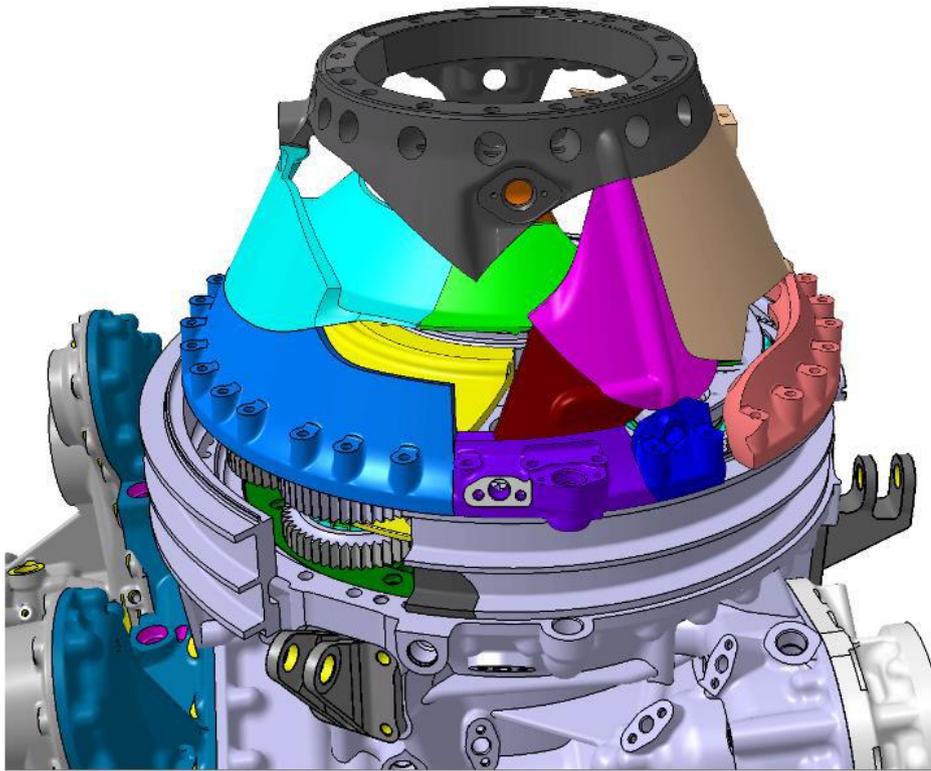
*Figure 51: Illustration of how the retrieved fragments of the conical housing are pieced together in order to look for break-up sequence/mechanism. Illustration: Airbus Helicopters*

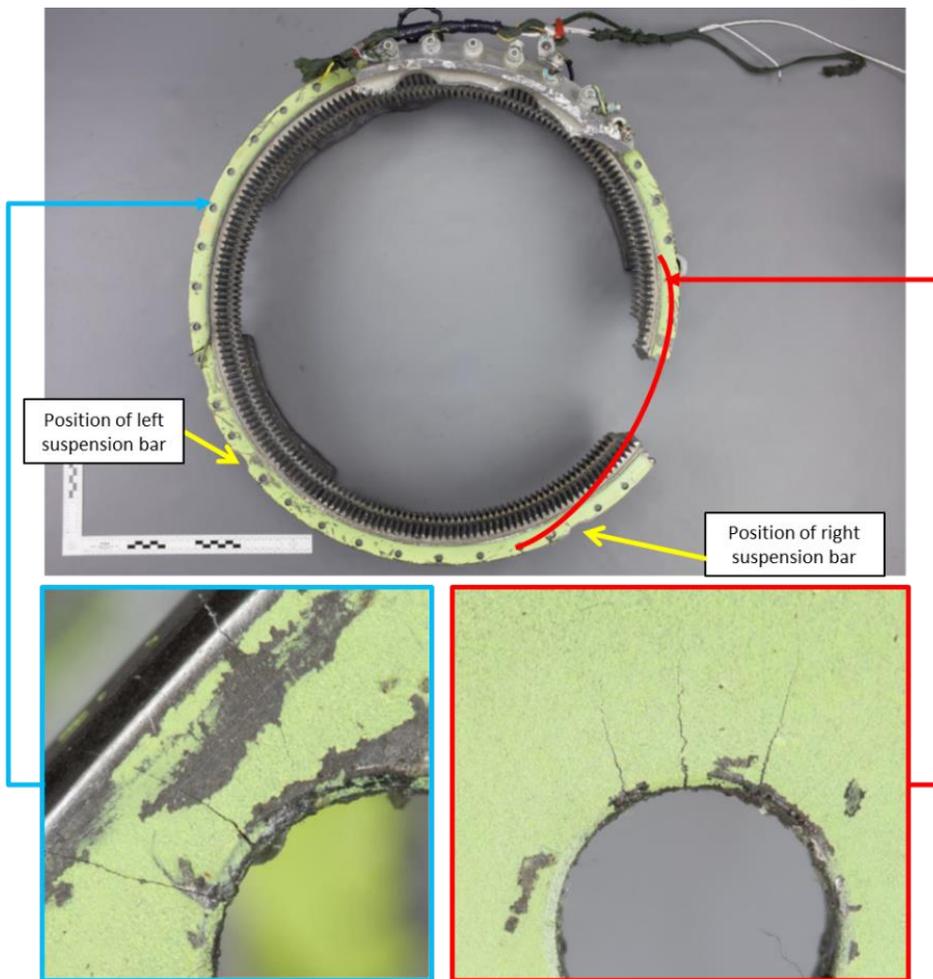
Figure 52: Epicyclic ring gear. Cracks at fastener holes suggests flange of conical housing were intact when fixed ring split and moved outwards. Photo: AIBN/QinetiQ

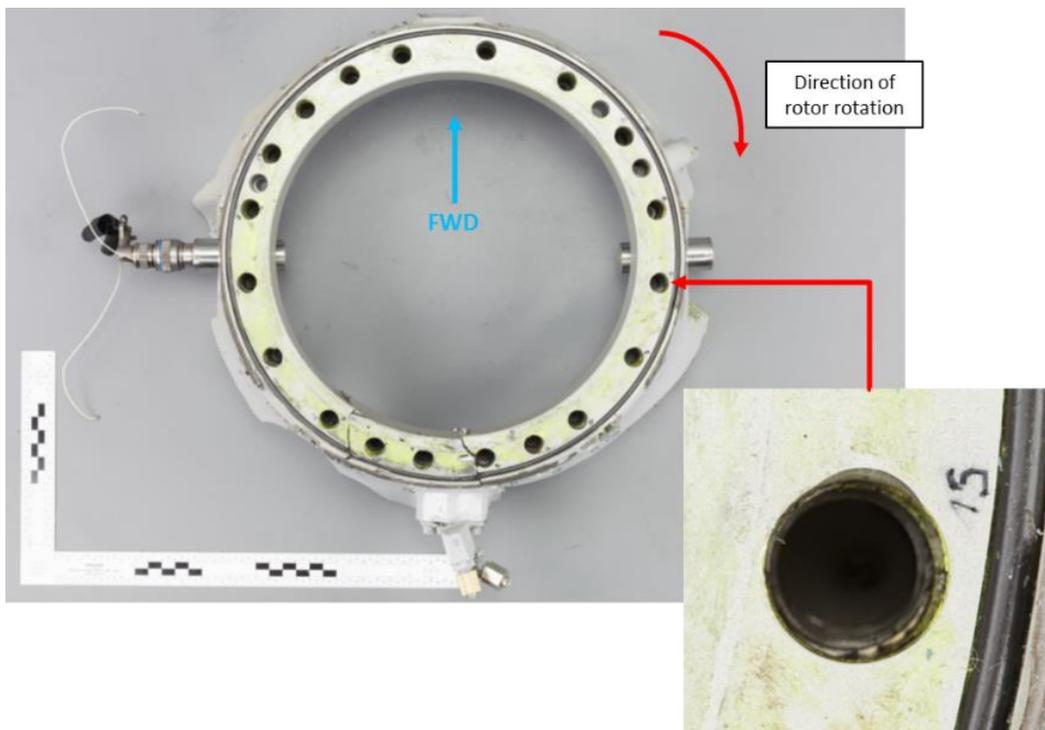
Figure 53: Top of conical housing. This segment of the conical housing was still attached to the rotor mast following the accident. Photo: AIBN/QinetiQ

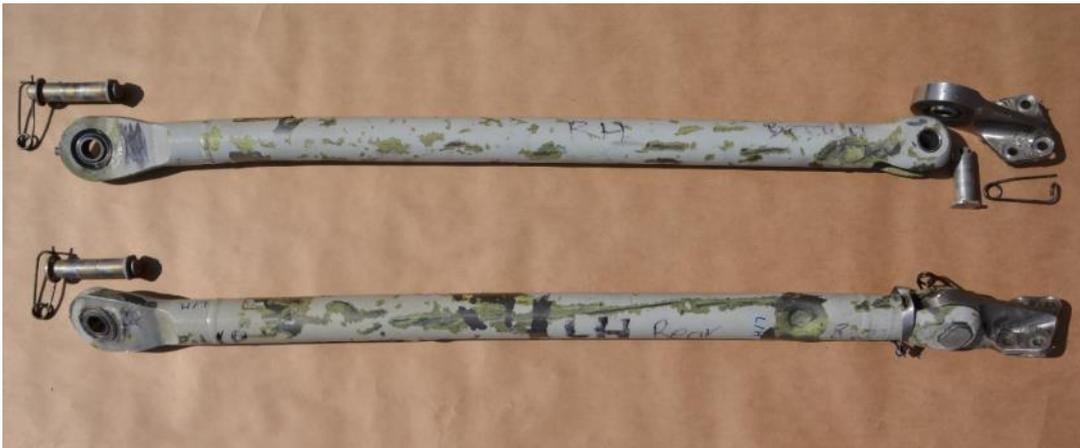
Figure 54: Left and right aft suspension bars with clevis pins, safety pins (only one shown in each position) and fuselage fittings. Both suspension bars have indentations from gear teeth.  
Photo: AIBN

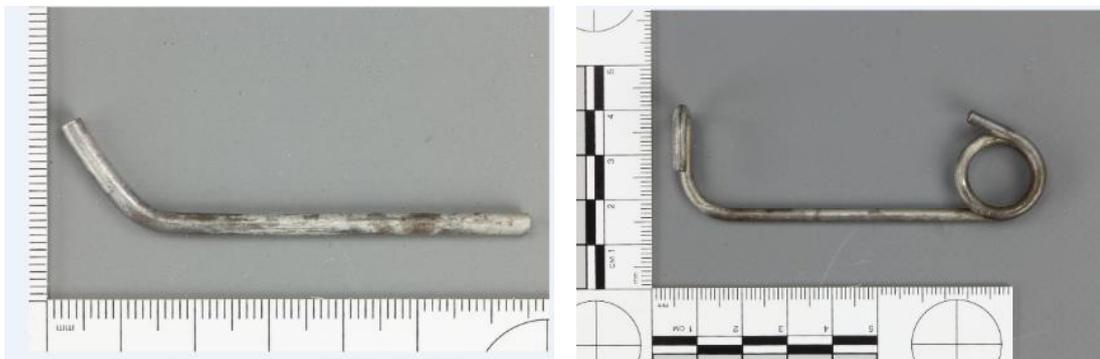
Figure 55: Two segments of safety pins found near the rotor mast. Metallurgical examination proved these to be from two different pins. Photo: AIBN/QinetiQ

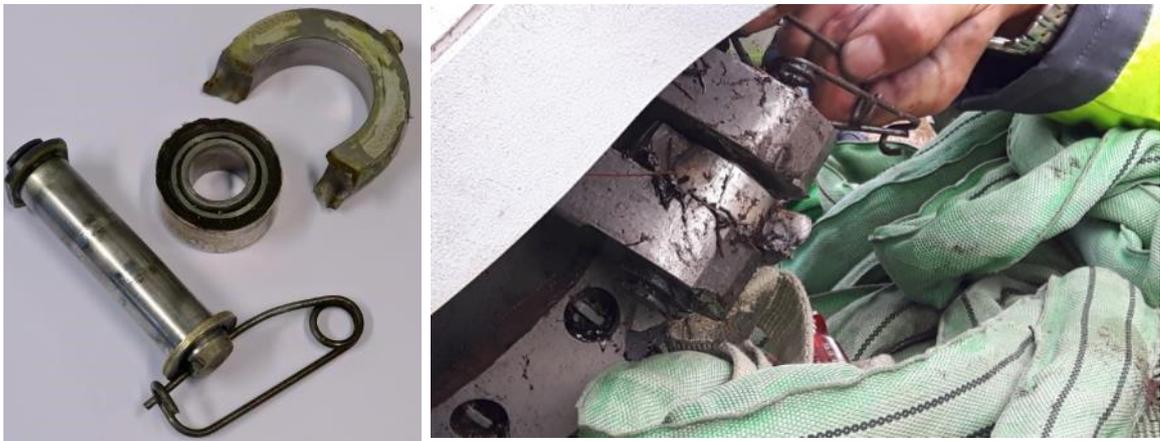
Figure 56: Upper forward suspension bar, part of the mounting lug, the bearing, the clevis pin (with only one of the two safety pins) and the safety pins. Here shown both as found at the rotor mast (right photo) and dismantled (left photo). Photo: AIBN

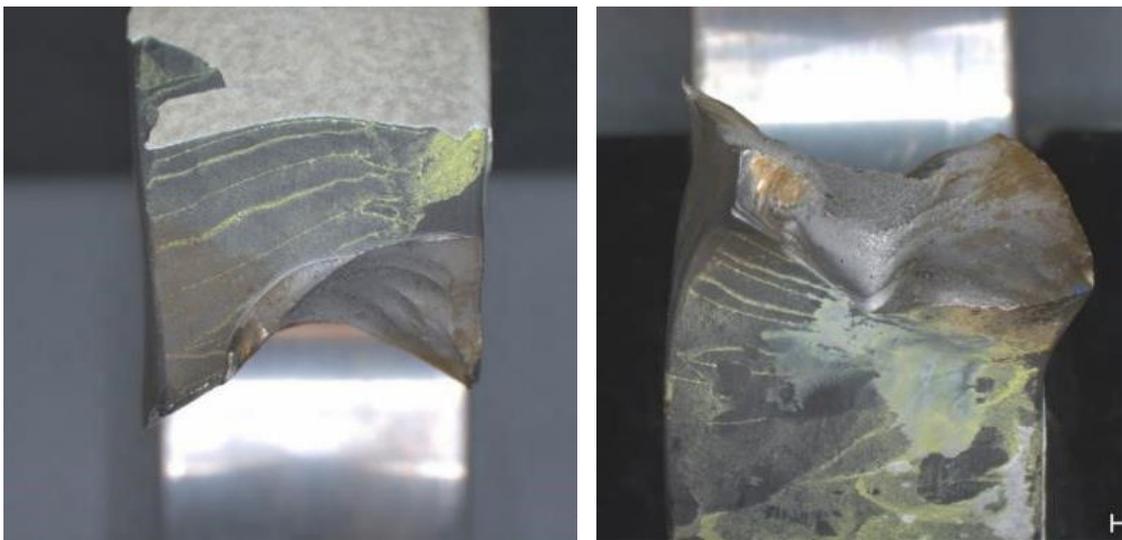
Figure 57: Upper forward suspension bar, mounting lug. Top fracture viewed from above (left photo). Bottom fracture viewed from below (right photo). Photo: AIBN/QinetiQ

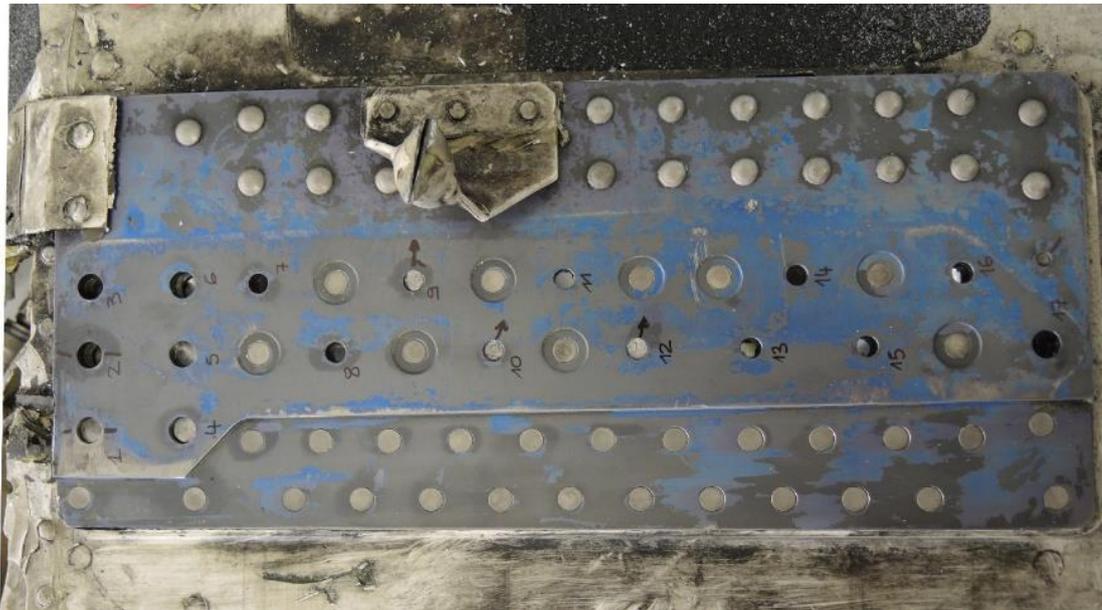
Figure 59: The flexible plate aft attachment had detached from the fuselage plate. 9 out of 17 bolts were still in place. Arrows indicating direction of overload in shear (towards the left relevant to the helicopter direction of flight). Photo: AIBN

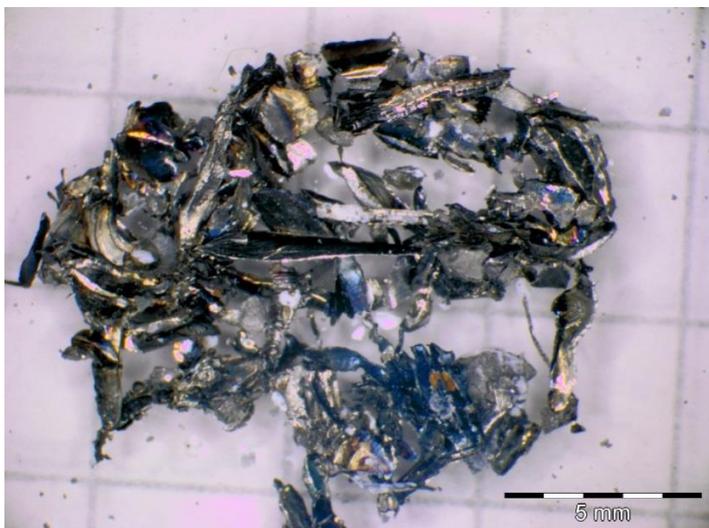
Figure 60: Metal particles from the MGB magnetic plug. Photo: AIBN/NDL

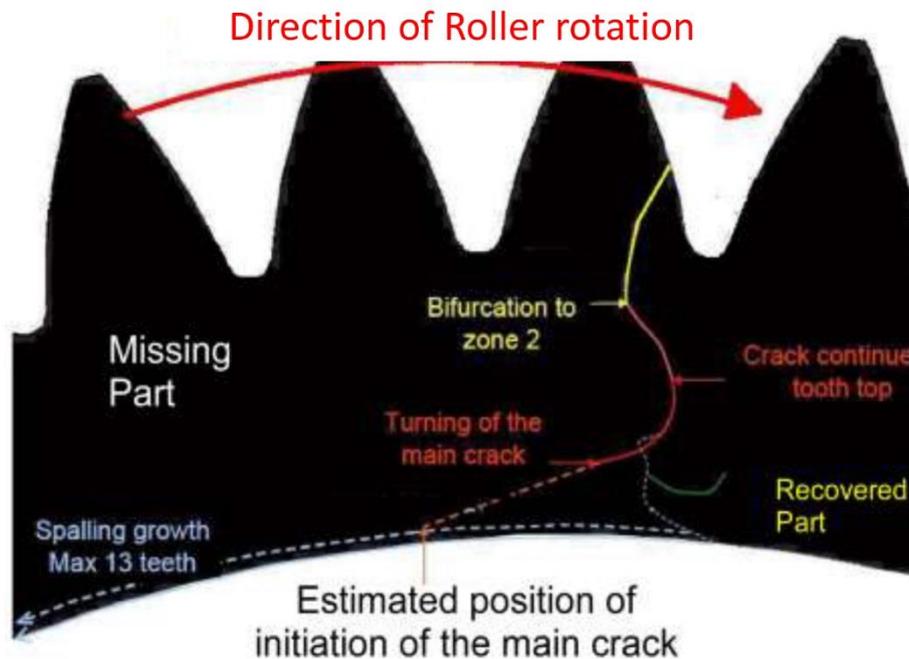
Figure 62: Stress model estimation of crack growth. Source: Airbus Helicopters

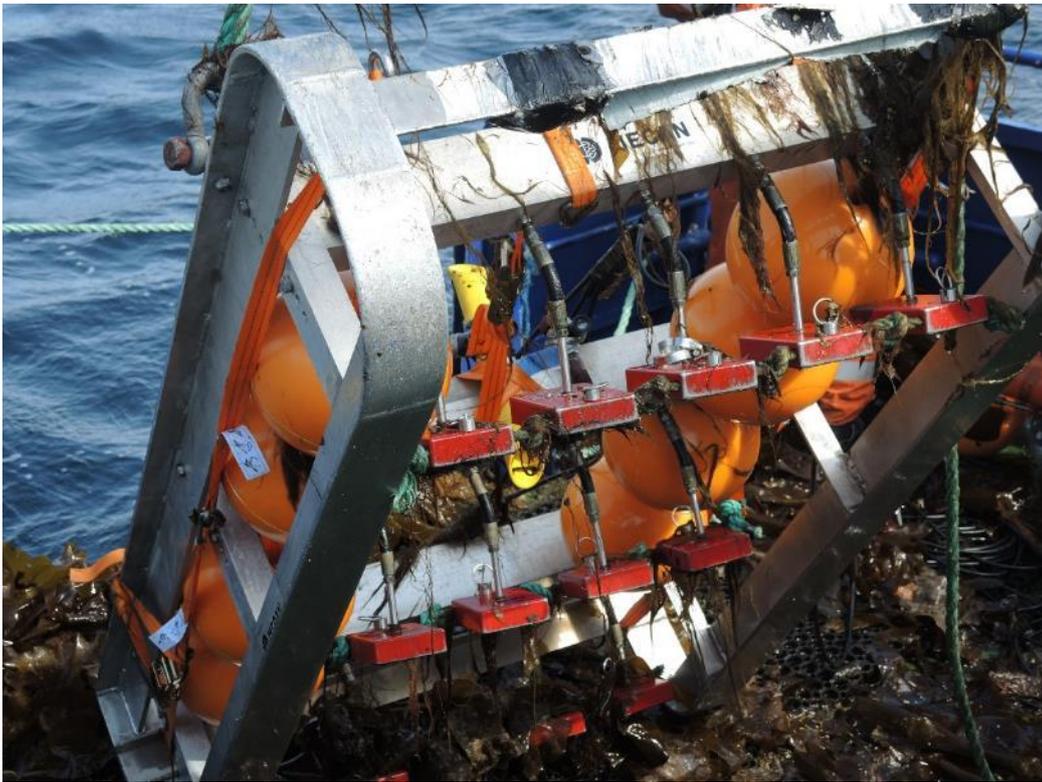
*Figure 63: The magnetic sledge being retracted from the sea. Photo: AIBN*
