MINISTRY OF COMMUNICATION
Civil Aeronautics Administration
Brussels

TECHNICAL INVESTIGATION REPORT
ACCIDENT TO HELICOPTER BELL 47G2
REGISTERED OO-ART
OCCURRED ON 1TH MARCH 1972

1130 HAREN, 14 February 1973.

ACCIDENT TO HELICOPTER BELL 47G2 - C4
REGISTERED OO - ART.
TECHNICAL INVESTIGATION REPORT

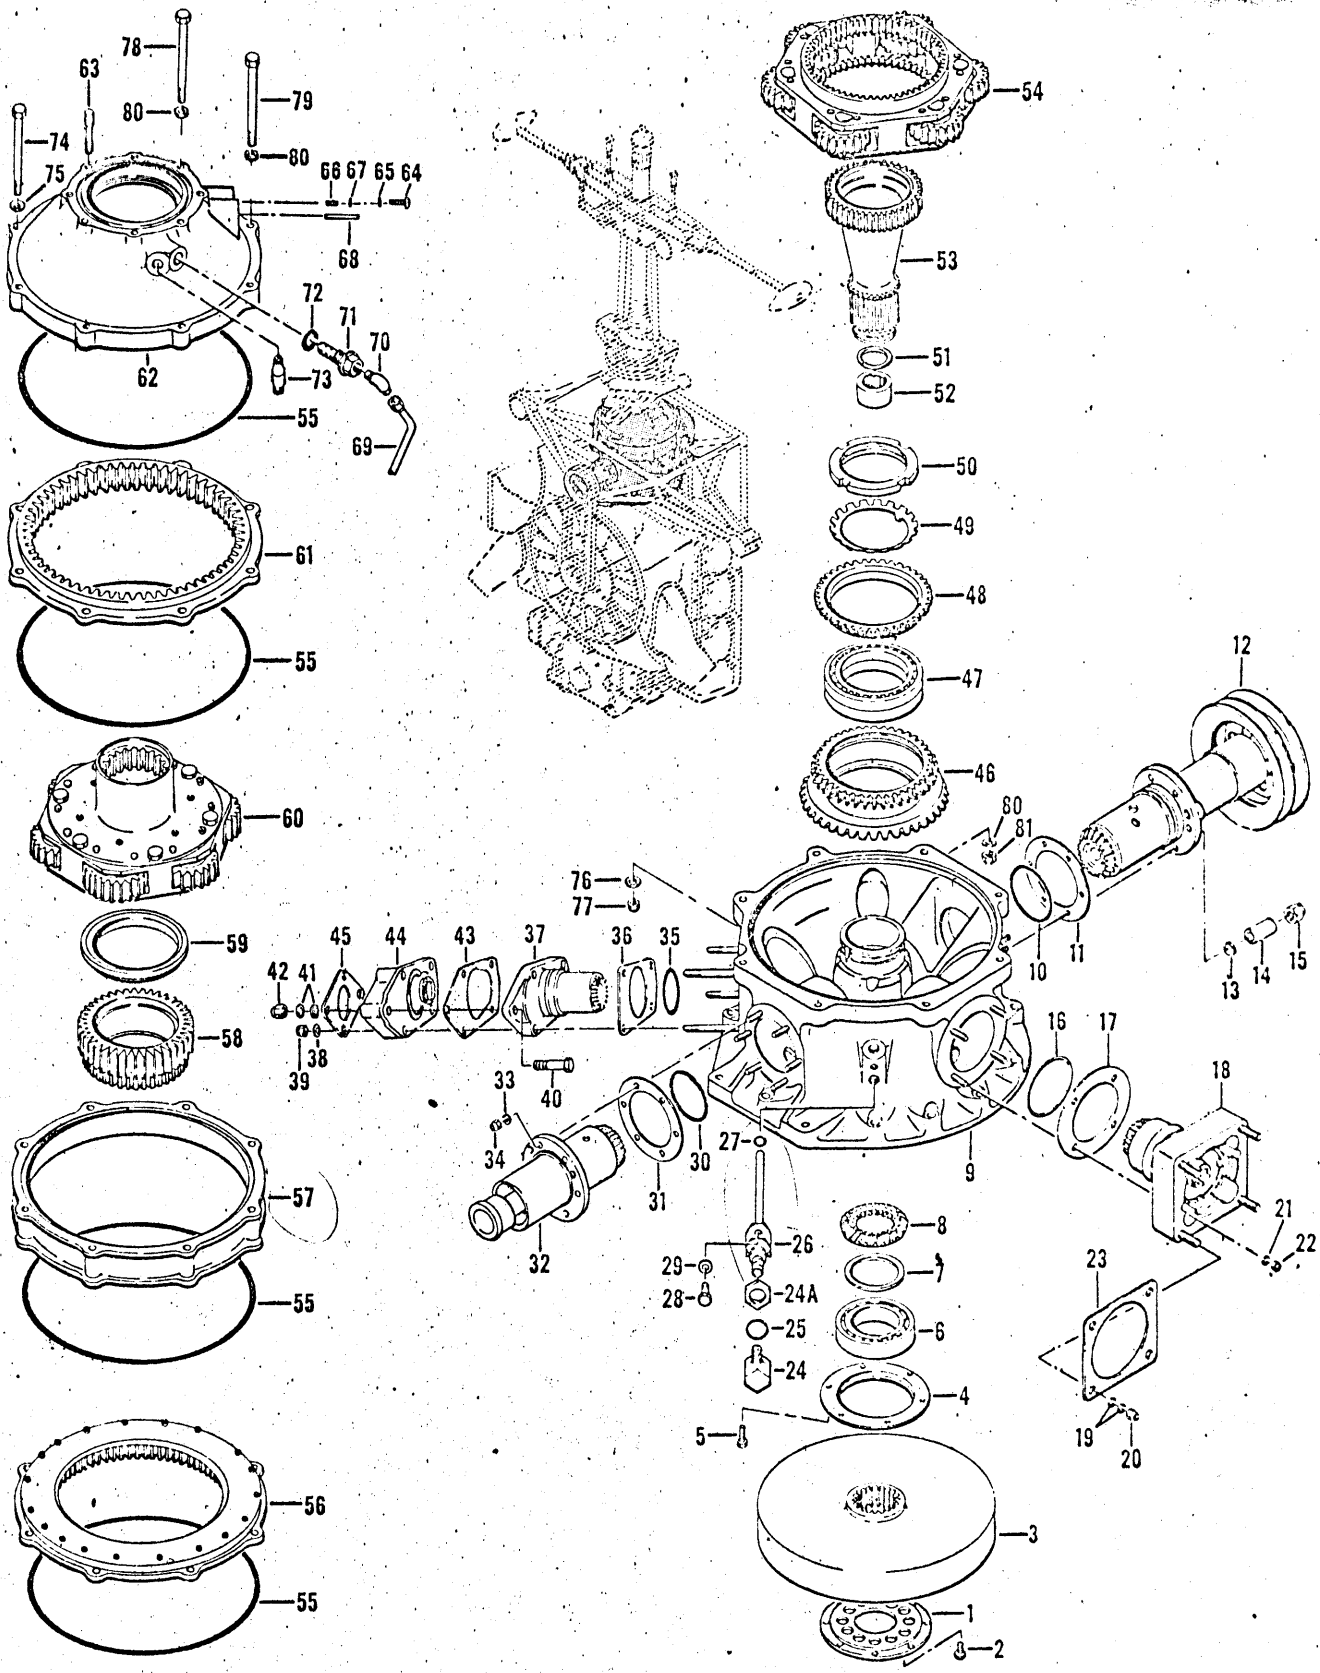
Figure 12. Main Rotor Transmission Assembly

The main gearbox and the rotor mast were completely disassembled in the following order, referring to figure 12, rev. 15.1.67, of the "Illustrated Parts Catalog" (figure in appendix) :
