Safety Investigation Report

ACCIDENT TO THE ROBINSON R44 II HELICOPTER REGISTERED OO-T** AT EBCF ON 01 OCTOBER 2011

Ref. AAIU-2011-24-EBCF-OO-T**
Issue date: 27 July 2012
Status: Final

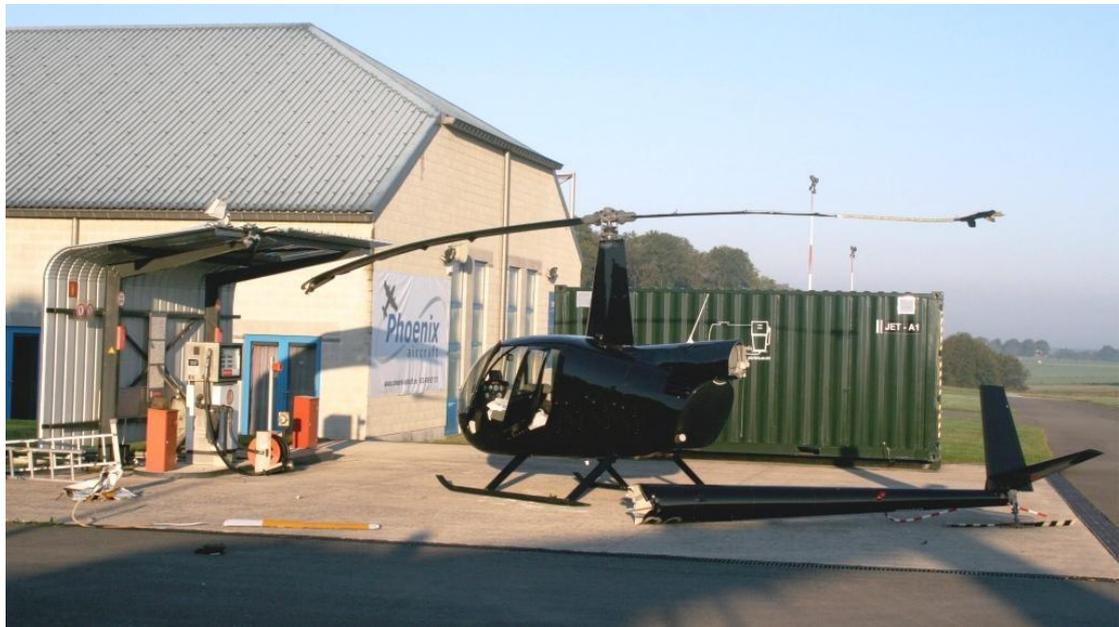
Figure 1: View of the helicopter and the refuelling installation.

As seen on the above picture the helicopter was severely damaged.

The main rotor blades collided several times with the roof causing the helicopter's skids to violently hit the ground in a rocking movement.

The main rotor blades were destroyed and it is likely that the entire power transmission and the flight controls accessories suffered extensive damage.

The tail structure was submitted to extensive and repeated shock loading when the main rotor hit the roof structure, accompanied by a rocking movement of the skids against the concrete surface. After a short period of time, the tail structure separated from the fuselage before the helicopter finally came to rest on its skids.

As well as the damage located at the tail structure separation, the structure of the fuselage showed a few structural deformations at different places.

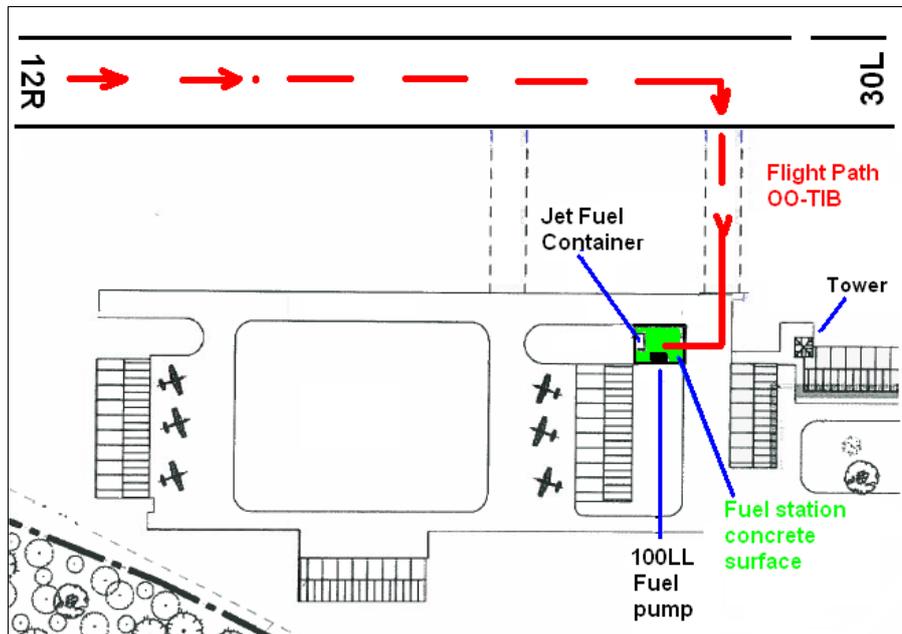
Figure 3: Location of the refuelling installation and flight path.

It is likely that the pilot experienced a small instability when he was hovering at 1 meter above the ground, close to the 100LL fuel pump.

To land on the concrete surface of the refuelling area, a helicopter's pilot has to adjust the helicopter hovering position in relation to two obstacles located perpendicularly; the 100LL fuel pump and the Jet A1 fuel container.

By contrast, the 100LL installation is less massive and the pilot would be obliged to evaluate several distances, for example those from the vertical wall of the 100LL fuel pump shelter would be more visible than the horizontal roof.

AAIU recommends the EBCF airfield's commanders to request to helicopter's pilots who want to refuel:

- *To land at a safe distance from both the 100LL Avgas fuel pump and the Jet Fuel container.*
- *To be provided with ground handling wheels.*
- *To move the helicopters manually toward the refueling installation.*

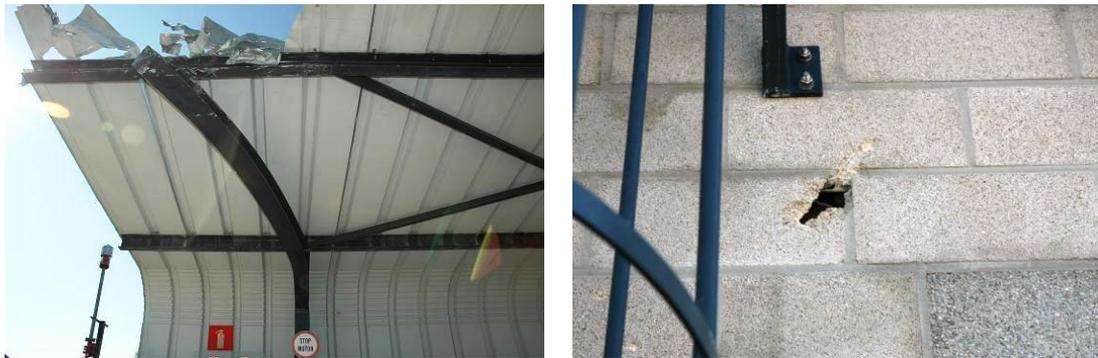
The corrugated iron and the roof's steel beams of the fuel pump house were significantly damaged. The concrete surface of the refueling area was also abraded by several impacts of the skids.

Several pieces of debris were projected toward the tower building located around 40 meters further, piercing a glass door, dust bins, and even a concrete wall.

Figure 4: Pictures of the roof's damage and damage to the concrete wall of the tower.

As seen on the above pictures (Figure 4), the beam of the roof structure which was hit by the main rotor blades was bent around 45°. The concrete wall of the tower building located around 40 m from the helicopter was pierced, probably by a flying main rotor tip weight.

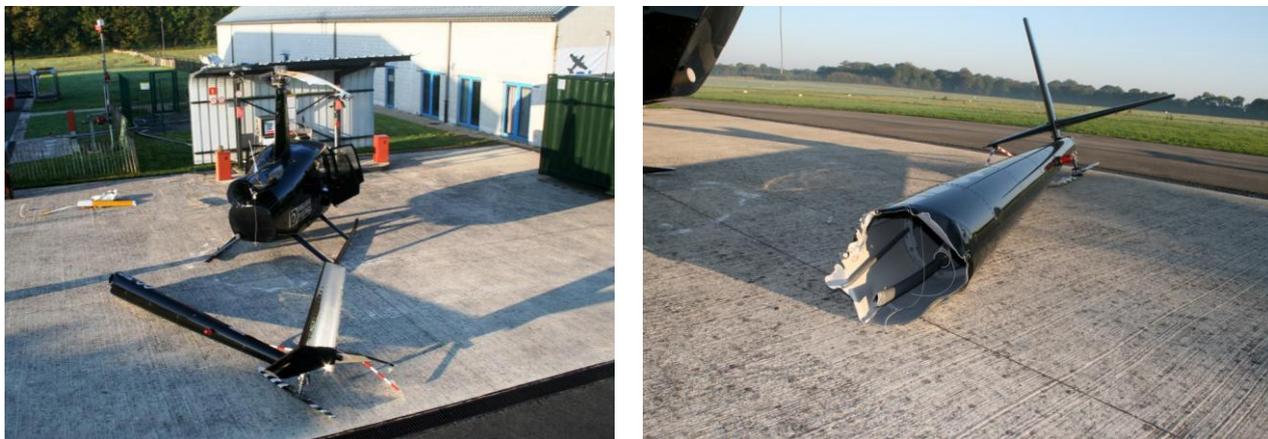
Figure 5: Damage to the helicopter.

The helicopter suffered damage on the main rotor blades and the separation of the tail rotor boom. The tail rotor blades were also damaged, but less significantly. Some deformation of the fuselage structure is also visible at several places.
