#### www.caa.co.uk/gasil

#### Issue no. 9 of 2011

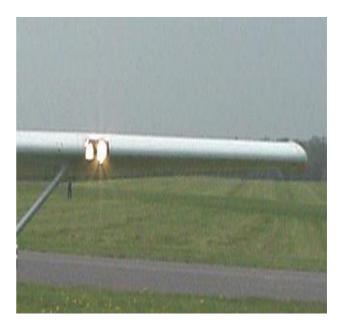
However, the occurrence database includes several instances of switches overheating, although usually with little damage caused. As readers of the Occurrence Digest will have noticed, one such incident was reported recently. It seems the switch could not be moved from the ON position, and the circuit breaker could not be tripped manually. Because the aircraft was on final approach, the landing was completed normally before the battery master switch was selected OFF and the landing light circuit isolated.
