FINAL REPORT ON THE ACCIDENT TO THE EUROCOPTER AS355F1 REGISTERED OO-HSB IN ZUIENKERKE ON 23-NOV-2008

**Ref. AAIU-2008-19-Zuienkerke-HSB
Issue date: 30-04-2009
Status: FINAL**

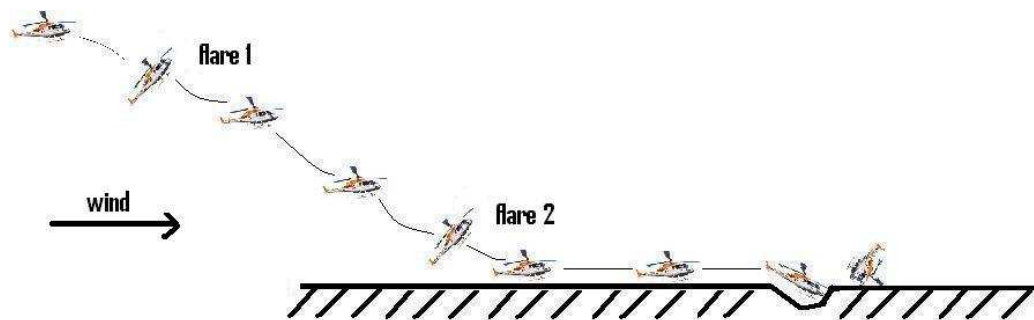
Figure 1: Schematic representation of the emergency landing and crash.

The helicopter skidded for about 20m. The nose and right skid hit the ditch making the helicopter to tip over on its right flank and to break up into pieces. After standstill, the pilot cut off engine power and all three persons crawled out of the wreckage.

During these events, which are graphically represented in figure 1, the helicopter continued to loose altitude.

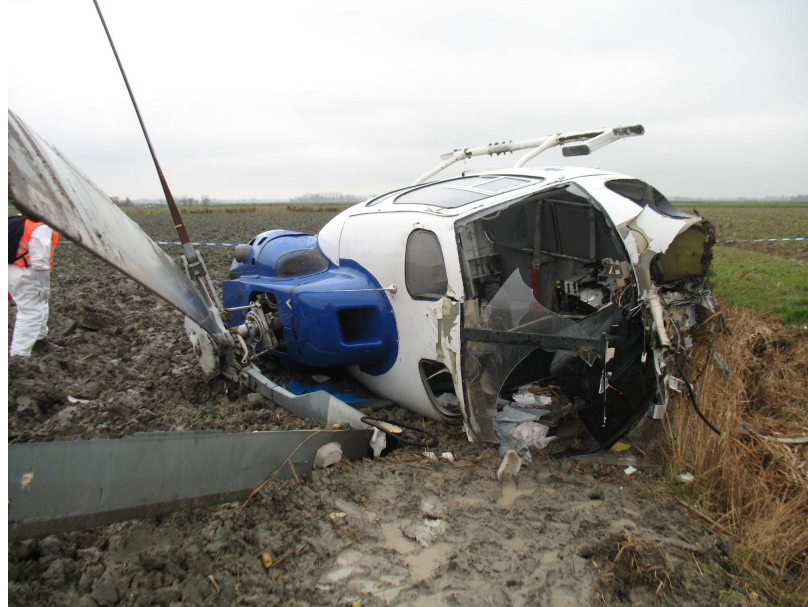
Figure 2: View of the OO-HSB wreckage.

The helicopter was destroyed; the tail rotor was ripped off, the main rotor was destroyed by the impact with the ground and the cabin was severely damaged as well.

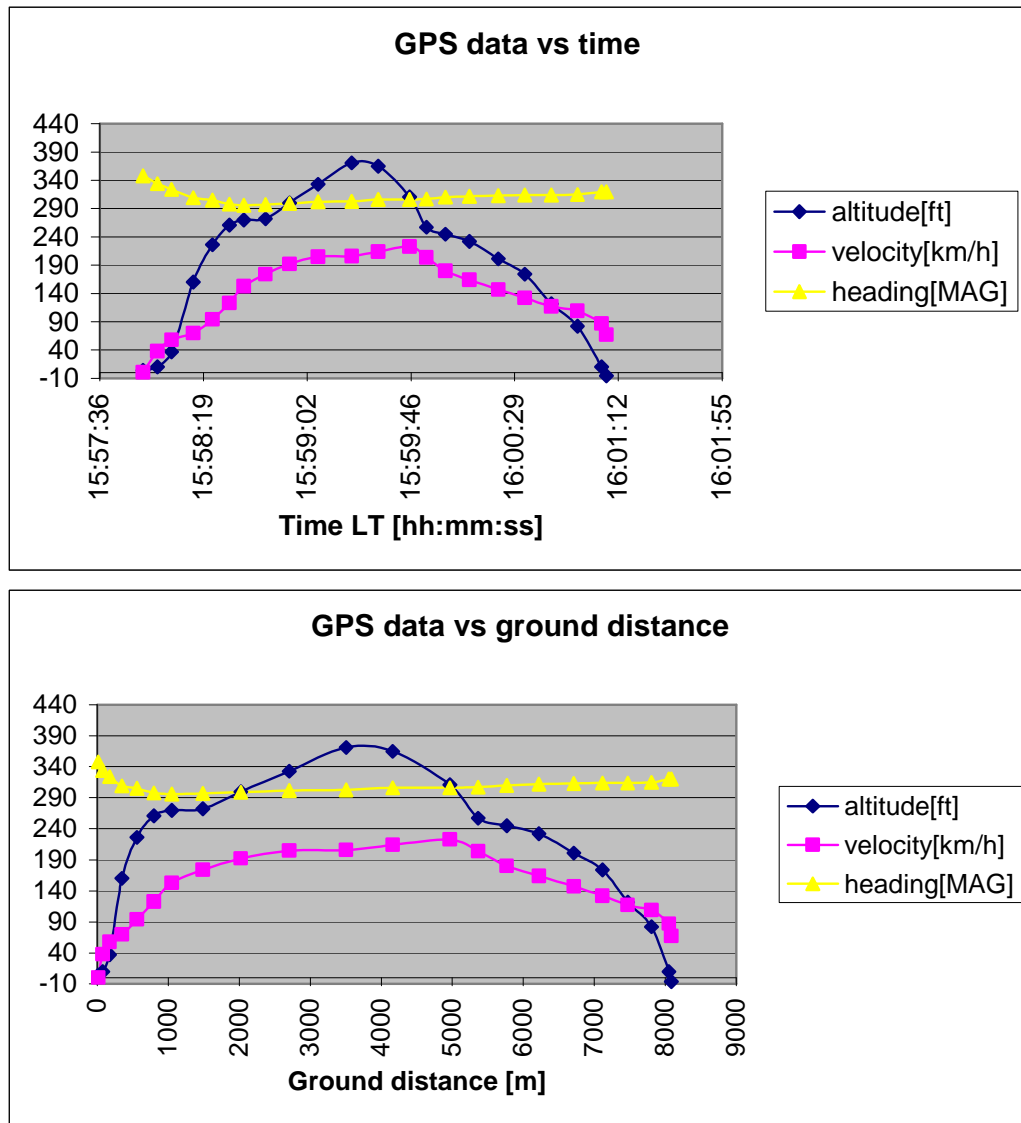
Figure 7: GPS data read out.

In this particular case, most of the flight was performed at velocities well above the optimal climbing speed (figure 7²²), which results in a rate of climb close to nil due to the increased drag the engine has to overcome (relative to optimal climb speed).

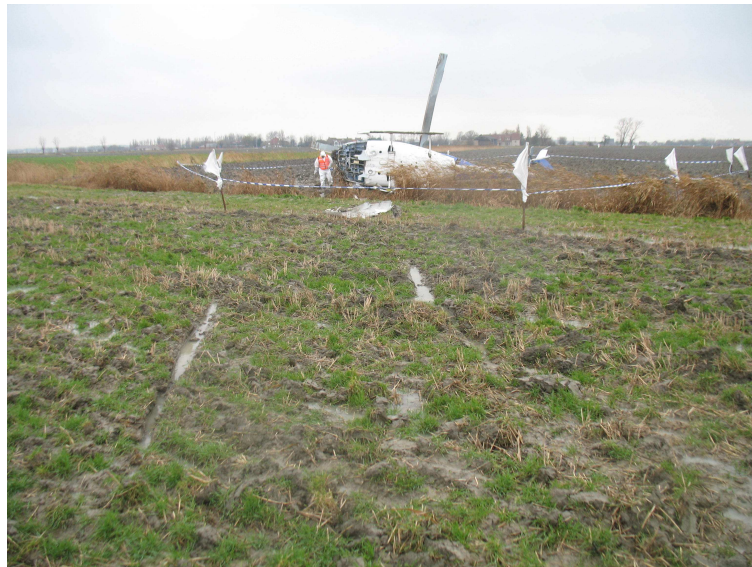
Figure 8: Skid marks in the ground.

Due to the high horizontal velocity at landing the helicopter slid over the moist ground, covered with snow and impacted a ditch about 20m further. The skid marks in the ground were clearly visible (shown below).

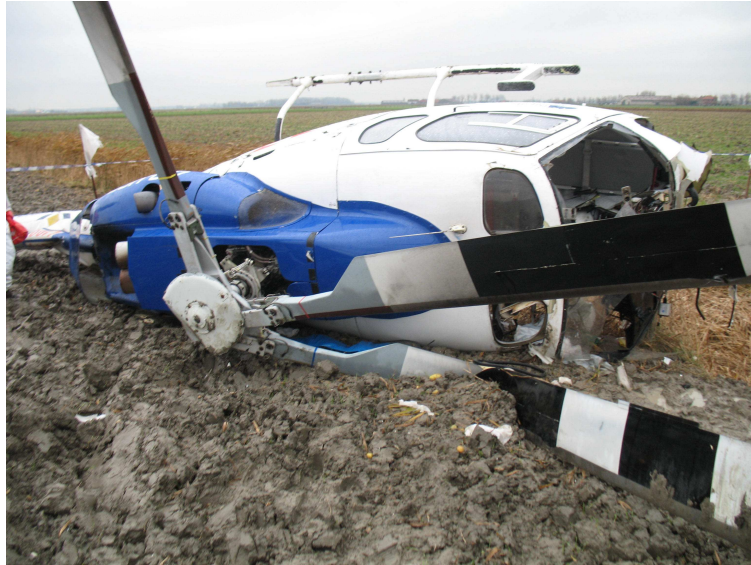
Figure 9: Damage incurred to OO-HSB.

As a consequence, the nose and right skid of the helicopter impacted the other side of the ditch and caused OO-HSB to roll over on its right flank, incurring substantial damage.

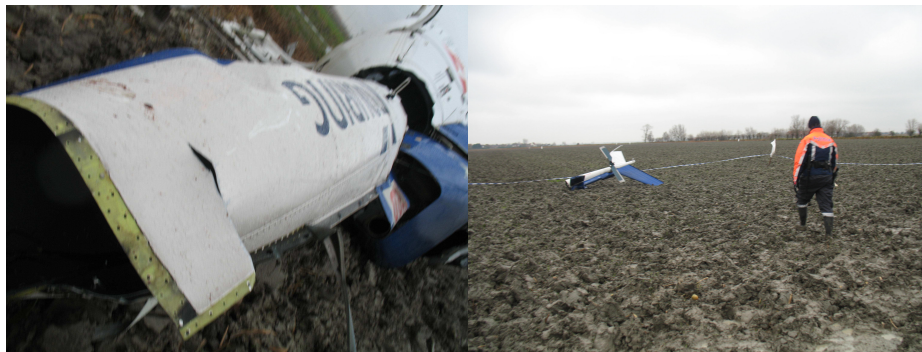
Figure 10: Tail boom and tail rotor of the OO-HSB

Due to the impact with the ditch, the tail boom broke and the tail rotor was projected away about 30m.

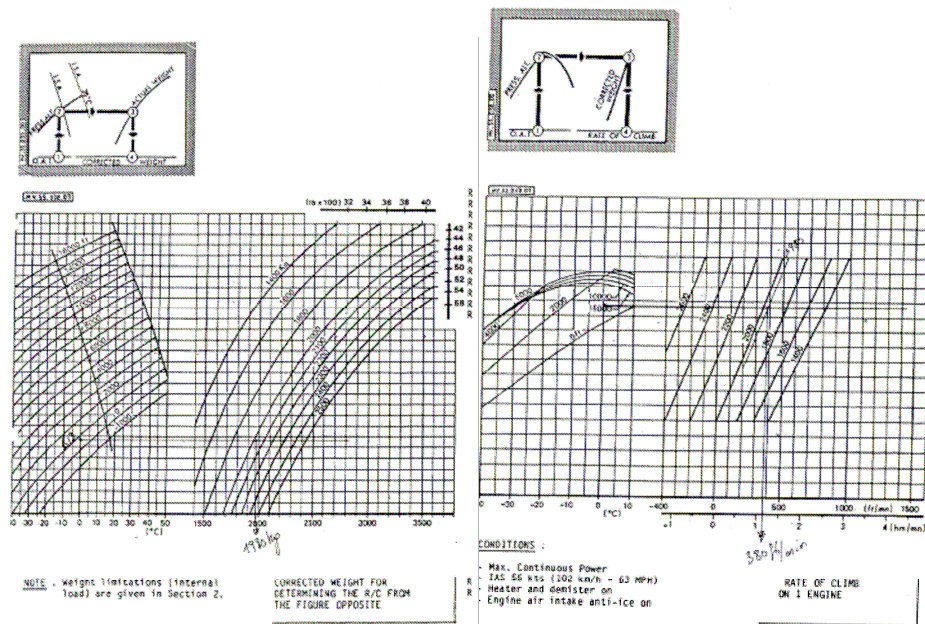
Although the helicopter is certified as performance class 1¹⁹, and thus should have been able to maintain altitude with OEI²⁰, following factors caused the helicopter to be unable to deliver the required power:

- The activation of the anti-icing, which reduces engine power,
- The activation of the cabin heater, which uses bleed air from the engines and causes the delivered power to drop.

Figure 12: Rate of climb at optimal climbing speed (IAS) with OEI and anti-icing, heater on.
