Federal Public Service  
Mobility and Transport  
Air Accident Investigation Unit

## Safety Investigation Report

### ACCIDENT SIKORSKY 269C AT EBCF AIRFIELD ON 13 JUNE 2014

Ref.:  
AAIU-2014-11

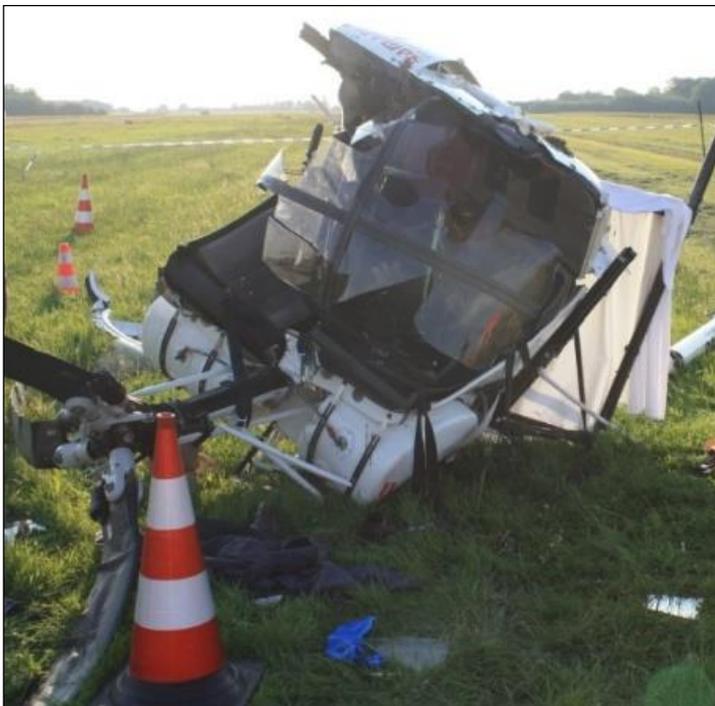
The first witnesses arriving on the crash site found the right side of the cabin in contact with the ground with the nose of the helicopter pointing approximately opposite the flight direction. They lifted the cabin to facilitate access to the victims in such a way that when the AAIU(Be) investigators arrived at the crash site, the front side of the cabin was directed upwards and the right hand fuel tank was in contact with the ground.

Figure 7: front side pointing upwards

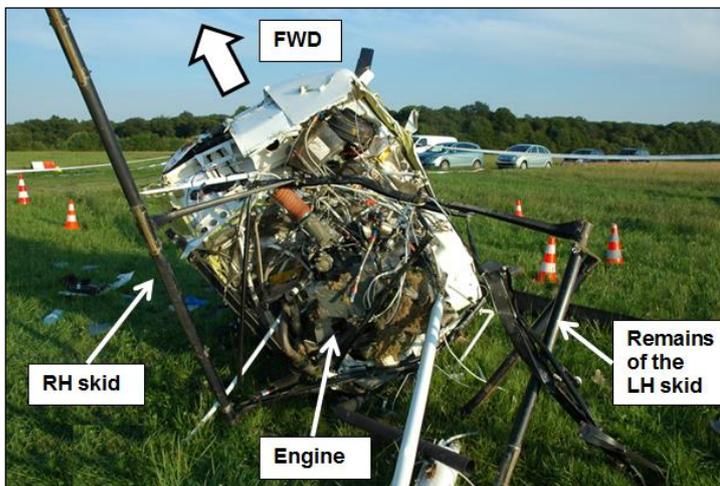
Figure 8: showing the underside of the wreckage

The main wreckage damage was essentially located on the lower side of the structure, including the lower side of the engine.

The left landing skid was totally destroyed including significant damage to the supporting structure. By contrast, the right hand skid was almost intact. In a general way, the impact damage was more extensive on the left side.

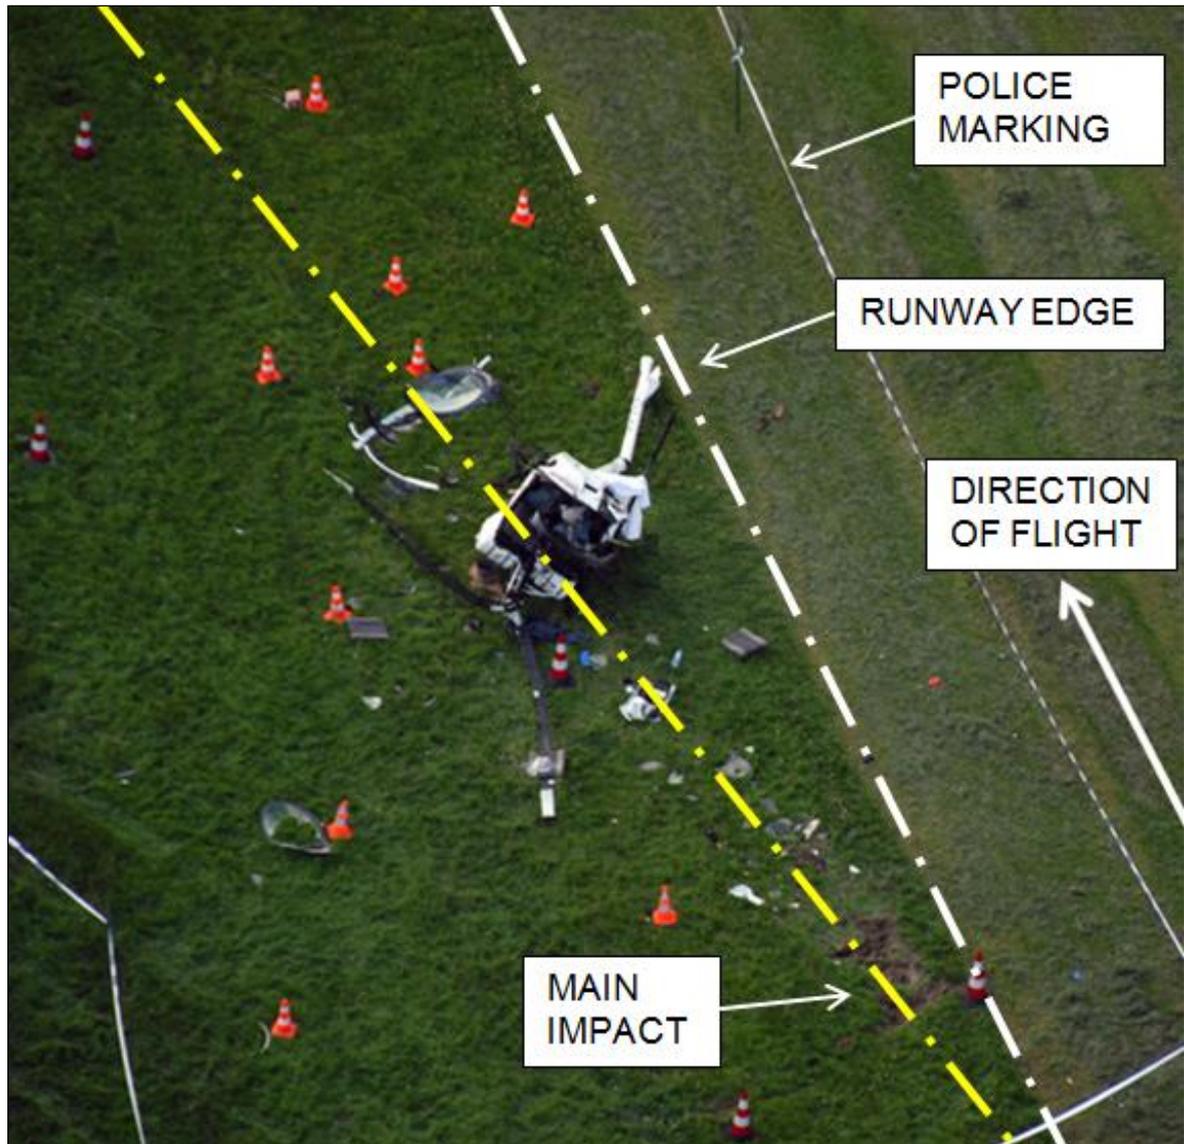
The first impact traces were originating from the skids. The cabin was located about 13,5 m further, with the tail boom beyond it with respect to the flight direction. The wreckage parts were scattered along an axis (yellow dotted line) pointing about 25° left to the axis of the runway.

Figure 9: Top view showing the approximate path of impact (yellow dotted line)

The debris pattern on the crash site, showing more separated parts on the left side of the wreckage and more significant damage to the left skid are consistent with the witness statement indicating that the helicopter yawed to the right while simultaneously falling down from an approximate height of 10 to 15 meters in the original direction.

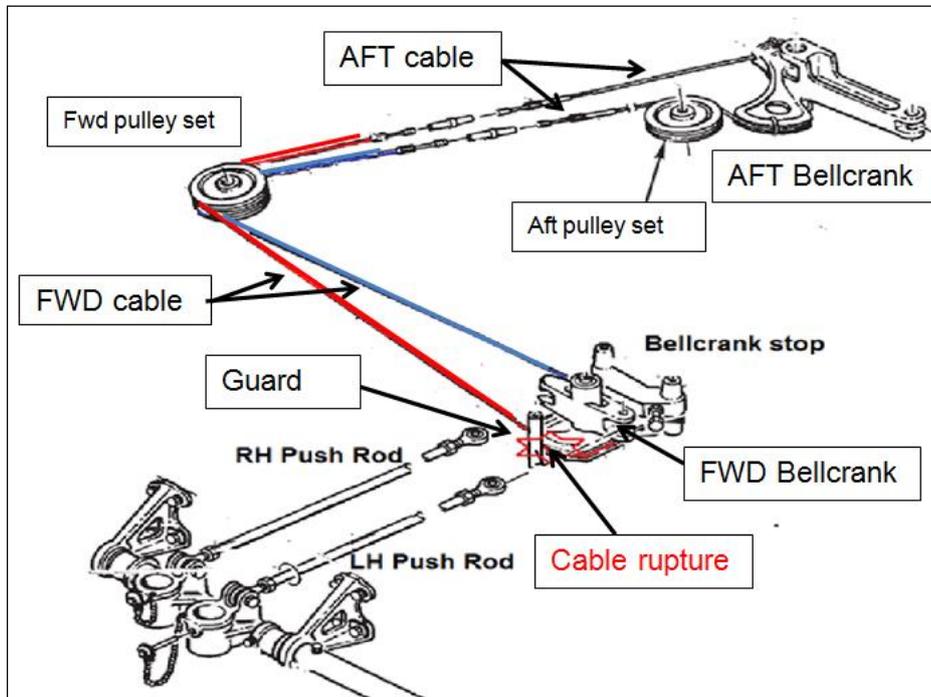
Figure 10: tail rotor control system

The control cable of the tail rotor was found broken at the forward bellcrank located under the flight compartment floor.

The rupture occurred at the location of the cable guard pin. Examination of the cable rupture shows evidence of cable friction both on the guard pin and on the groove of the Bellcrank.

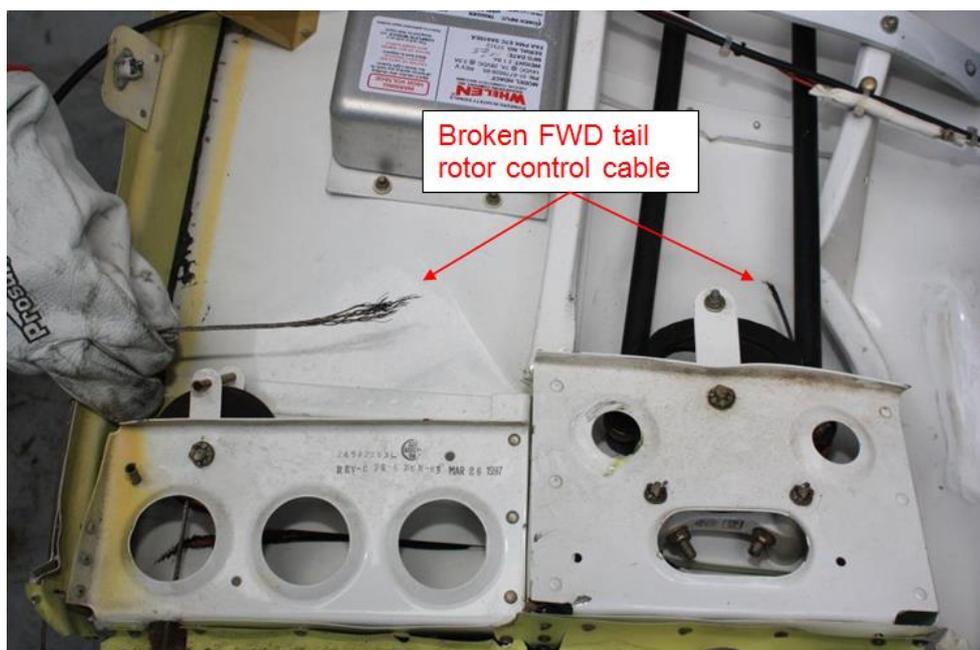
Figure 11: broken control cable

Thorough examination of the cable wires shows some of them are extremely worn and black “oily” by-products are also visible in the area of the cable rupture.

Therefore, it can be concluded that the cable failure occurred due to the structure deformation when the helicopter impacted the ground. The rupture of the cable took place at the weakened worn area of the cable located at the forward bellcrank.

Sikorsky Aircraft Corporation, notified of this finding, issued on 21 November 2014 two Alert Service Bulletins ASB B-306 and ASB C1B-042 requiring a one-time inspection with a request for a response on the conditions found. There were several responses that indicated that the engineers found wear. As a solution to this issue, a temporary revision<sup>5</sup> dated 14 July 2015 has been issued to the HMI Appendix B calling for a 400 hour periodic removal of the cable for inspection. In place cable inspections already existed in the manual but the addition of an inspection of the cable while removed will expose those cables that are wearing and force their replacement.

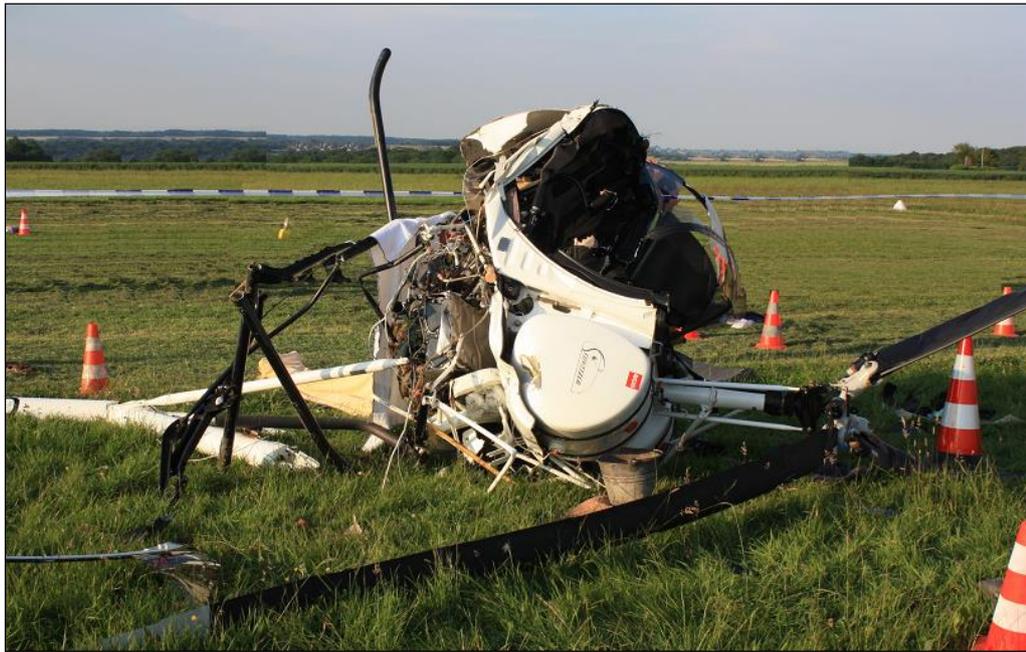
The tail boom was severed and was lying next to the main wreckage.

The 3 main rotor blades exhibited no important bending, which is consistent with a low rotational energy at ground impact.

Figure 12: tail boom on the left – rotor blade in front showing no major bending

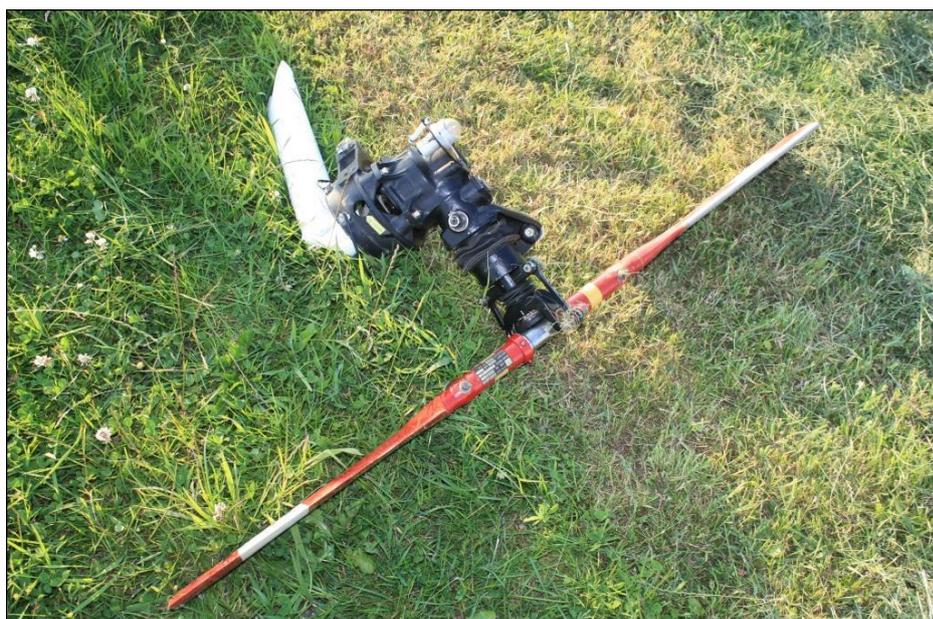
The furthest separated part found was the tail rotor, located about 32 m from the skid traces.

The tail rotor blades didn't show any trace of rotational impact either.

Figure 13: The tail rotor was found torn away from the tail boom

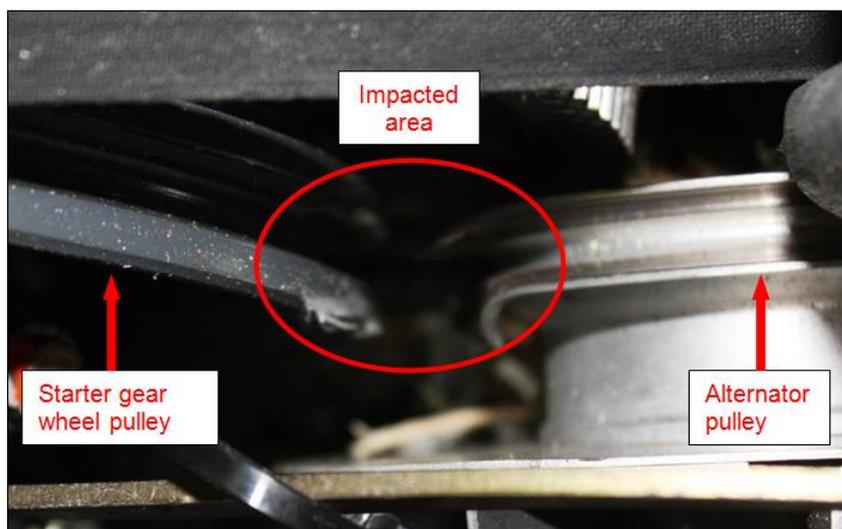
Engine and engine accessory external examination could determine that the alternator was moved upwards, in the direction of the starter gear wheel due to the helicopter impact with the ground. This caused the alternator pulley to collide with the starter wheel pulley.

Inspection of both pulleys determined that there was only one single matching bent on each pulley, without any circumferential friction mark. This definitely demonstrates that the engine was no longer running at the time of the ground impact.

Figure 14: only local impact damage, showing there was no rotation on impact

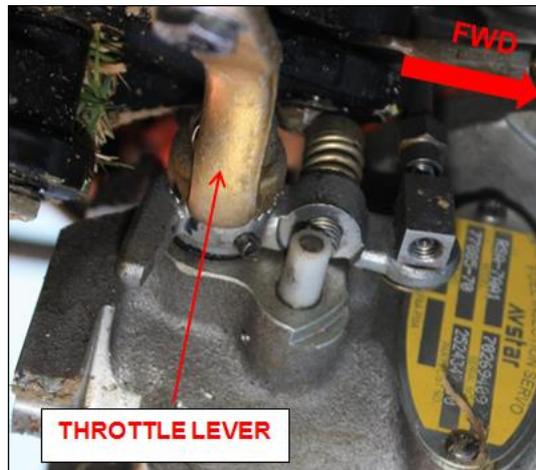
The throttle valve, located inside the fuel injection body, was found with its stop in contact with the idle adjustment screw, in closed position. The throttle lever was found bent upwards and was also slightly twisted backwards, which suggest a rotating movement of the lever towards the close position on impact. The above mentioned damage to the throttle lever and to the correlator system made it impossible to determine the position of the throttle control on impact.

Figure 15: throttle lever bent upwards

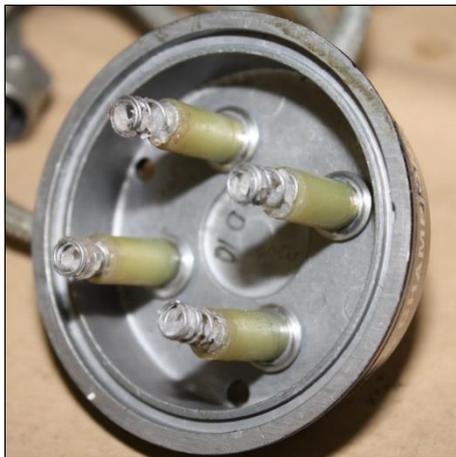
Figure 16: grease on the HT leads spring ends

The presence of a clear grease on all HT lead spring ends and also inside the corresponding receptacles in the distributor blocks, while not recommended by the magneto's manufacturer, does not appear to affect the electrical connection between the magnetos and their HT leads. Post-accident test benching of the magnetos equipped with their HT leads showed a normal working of the ignition system.

However, this test cannot completely exclude possible adverse consequences of this grease. Therefore, shortly after the accident, AAIU(Be) recommended the maintenance organization conduct an internal investigation aiming to determine why the grease was put at this location, in order to avoid such an inadequate maintenance action in the future.

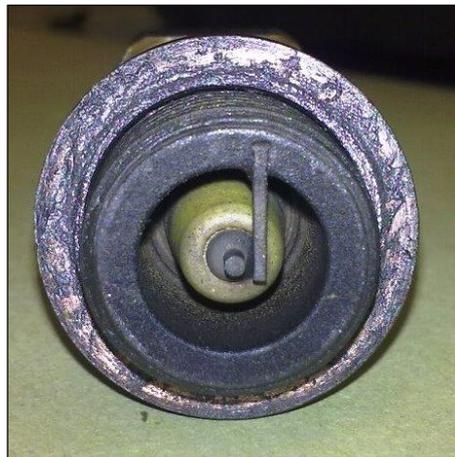
Figure 17: electrodes of one spark plug

- The test of all 8 spark plugs, using a spark plug tester, showed that 7 of them were working properly, including the bent one. By contrast, one spark plug without visual damage didn't deliver any spark. All spark plugs were tested a few times under different air pressure with the same result.

A non-visible internal damage to the insulator of the spark plug, caused by the shock of the impact, cannot be excluded. However, there is a possibility that the deficient spark plug stopped operating during the flight. This hypothesis is supported by the fact that another spark plug, severely damaged during the accident, was still operating.
