# FINAL REPORT

*97-74/A-25*

*PH-KHB, Sikorsky S-76B*

*20 December 1997, near Den Helder*

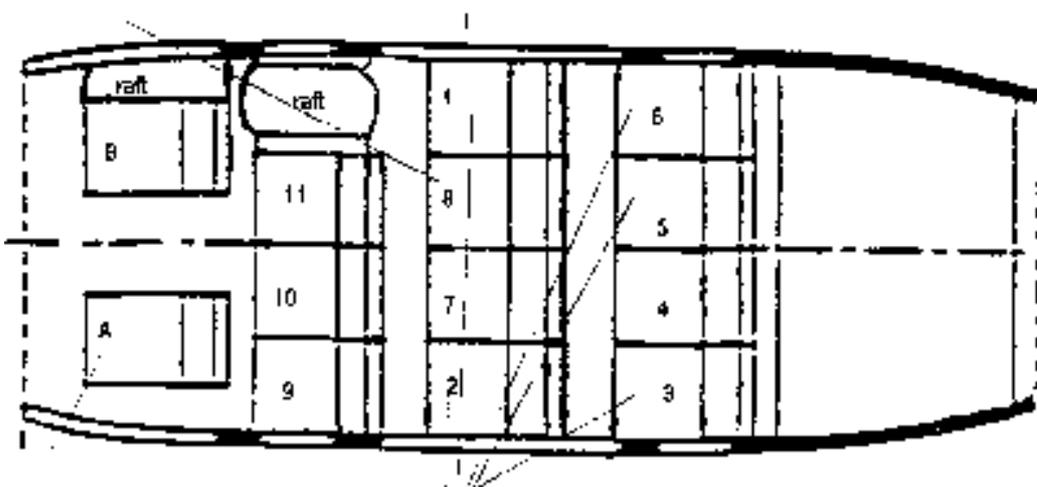
During the accident flight positions A, B, 1, 2, 3, 5, 6 and 8 were occupied.
