**FINAL REPORT ON THE ACCIDENT
TO ROBINSON R44 II REGISTERED
OO-PTA IN ZEEBRUGGE ON
11 MARCH 2011**

Ref. AAIU-2011-04
Issue date: 22 August 2011
Status: FINAL

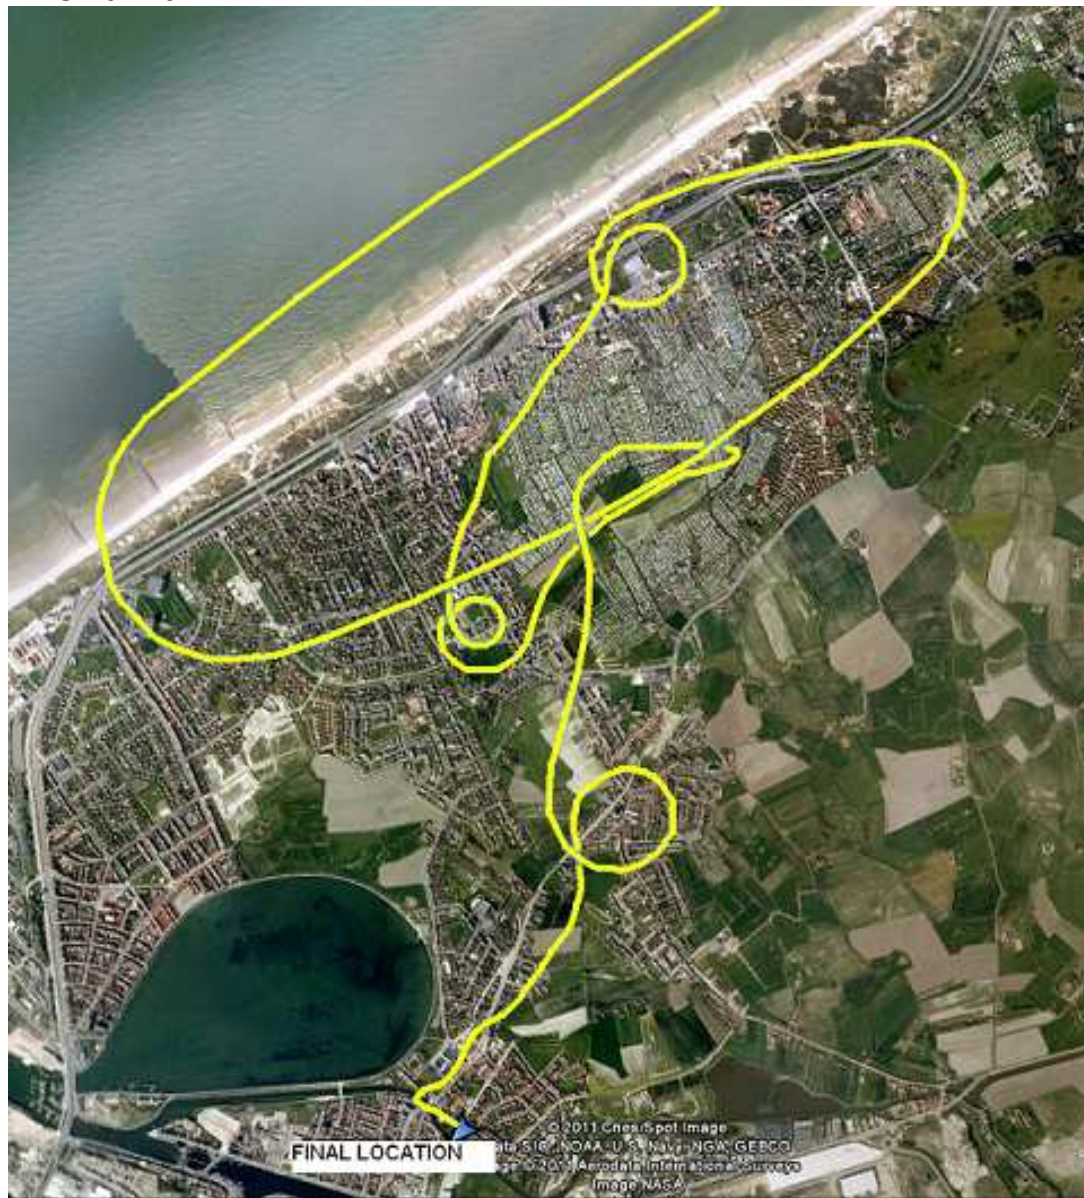
Flight track above Bredene city

The helicopter flew above Bredene and surroundings at an altitude ranging from 200 to 400 ft agl.

After flying around the water tower of Bredene, the helicopter flew south, in the direction of the Nukkerwijk, and the Nukkerbrug, where the 150 kV power Line Brugge – Slijkens (150.15-16 (EV204)) runs.

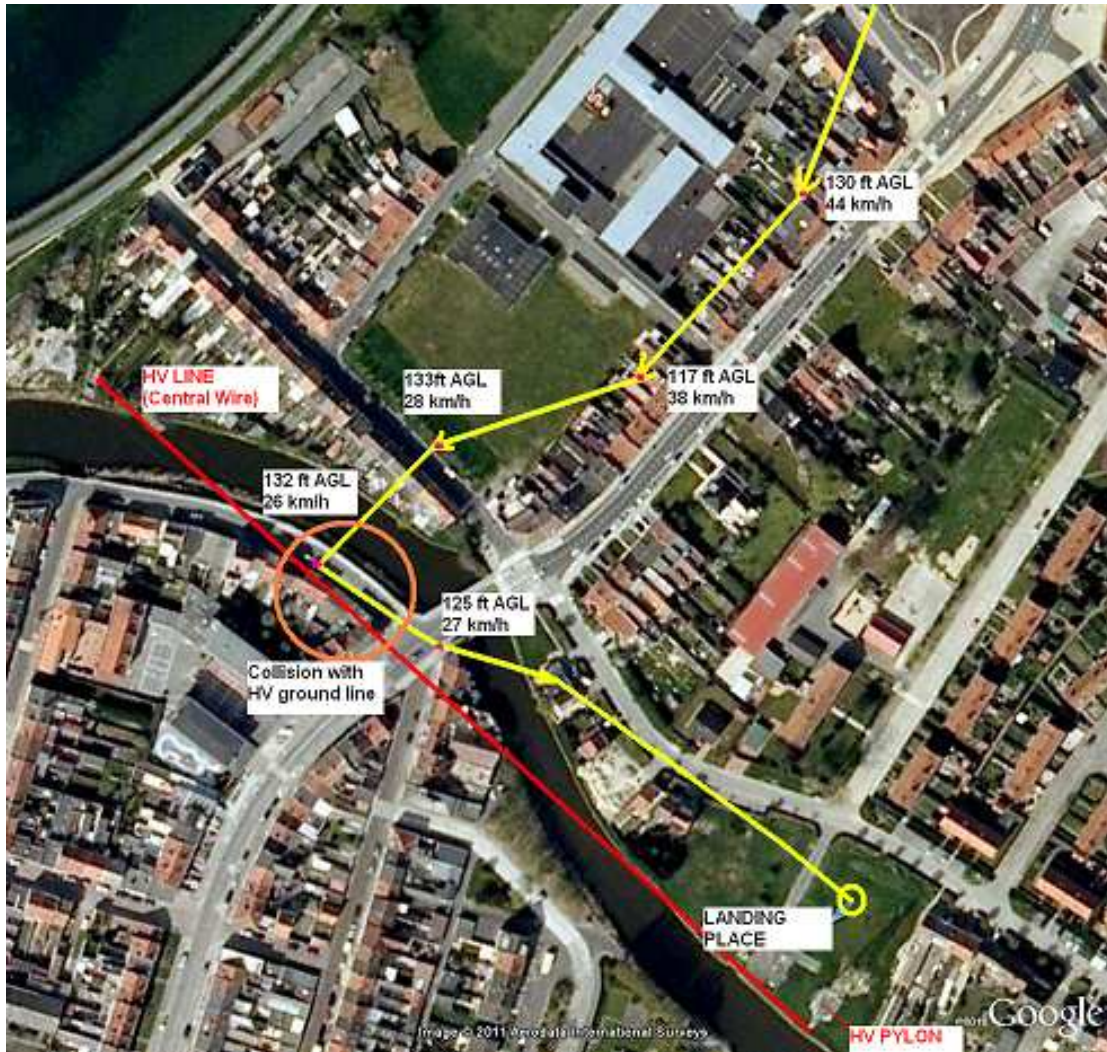
Flight track in the vicinity of the HV Line

The helicopter path was perpendicular to the HV power line. When coming in the vicinity of the bridge, at a height of 130ft, the helicopter turned left.

The pilot did not notice the presence of the HV line until he saw a shadow, followed by a loud bang.

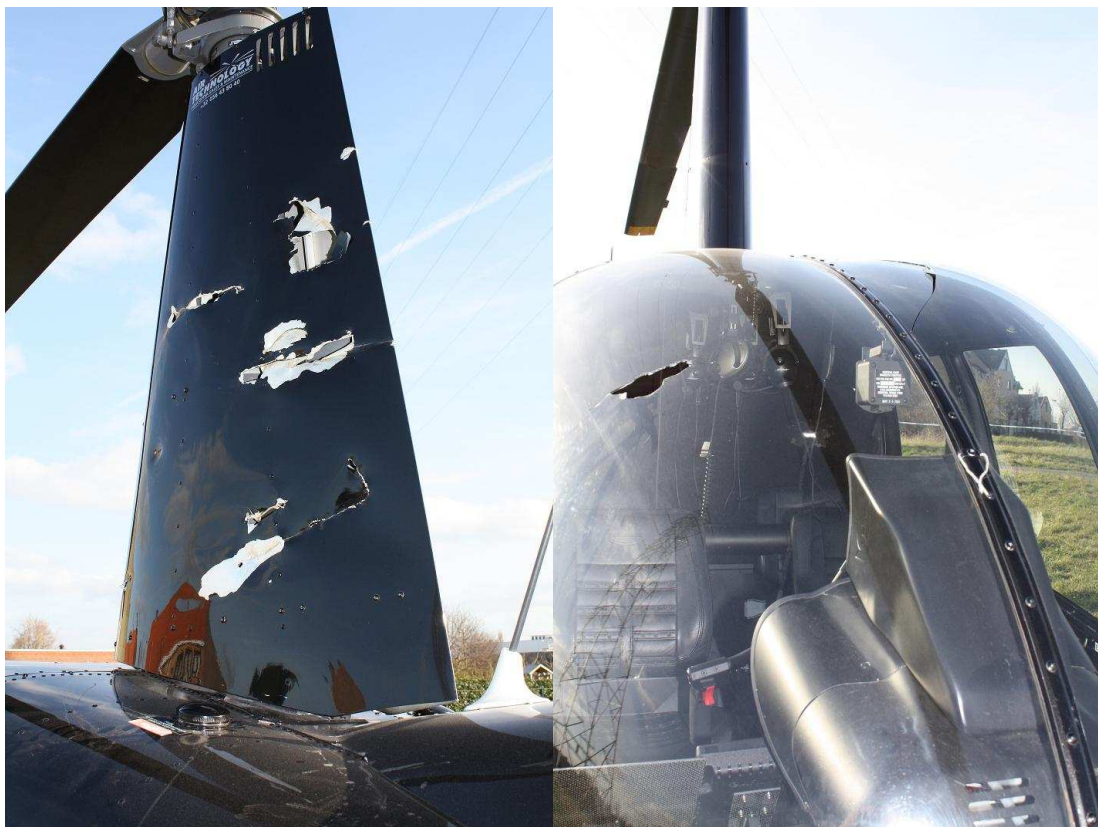
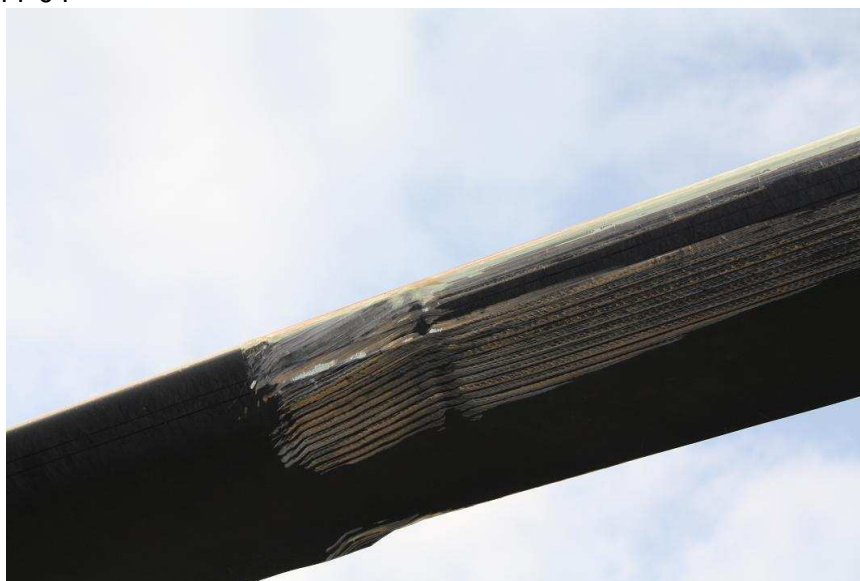
The airplane sustained damages to ;

- the main rotor,
- the rotor mast,
- the windscreen and the cabin structure is punctured.

The helicopter severed the ground cable of the power line with the main rotor. The cable itself caused some impact damage to the forward windscreen, the mast cover, and to other locations.

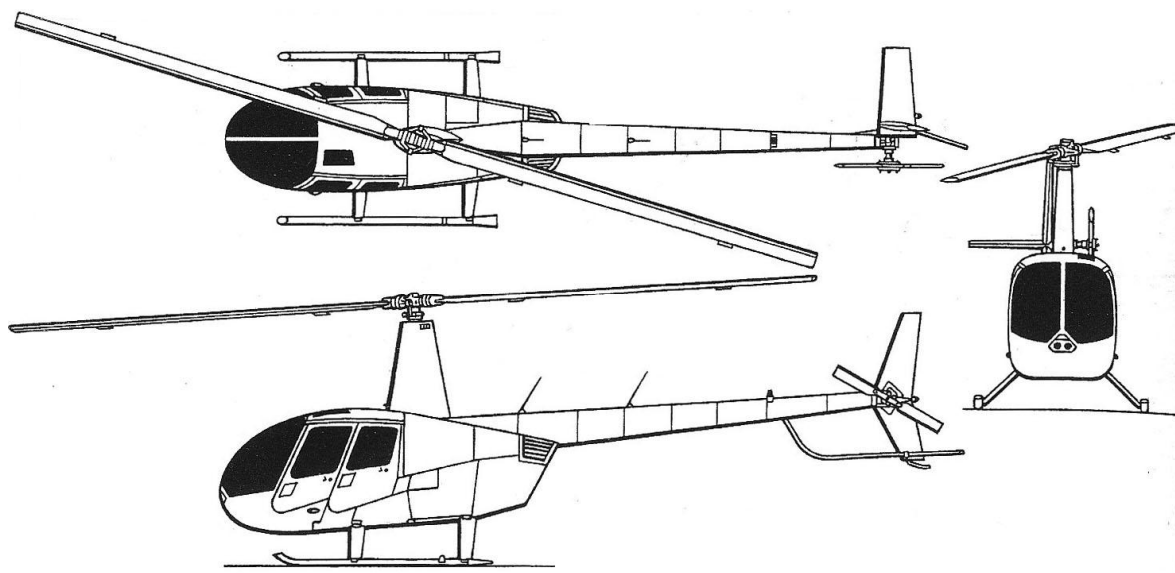
- **Crew:** one or two pilots
- **Capacity:** four, including pilot
- **Payload:** 900 lb (408 kg)
- **Length:** 21 ft 5 in (9.0 m)
- **Rotor diameter:** 33 ft (10.1 m)
- **Tail rotor diameter:** 4 ft 10 in (1.5 m)
- **Height:** 10 ft 9 in (3.3 m)
- **Empty weight:** 1,450 lb (657.7 kg)
- **Loaded weight:** 2,500 lb (1,134 kg)

Taking into account that the main rotor cut the ground line 1m from the extremity of the blade, that the diameter of the rotor is 10.1m, and the helicopter height is 3.3m, the risk of contacting a phase power line (minimum distance: 4.5m) was high.

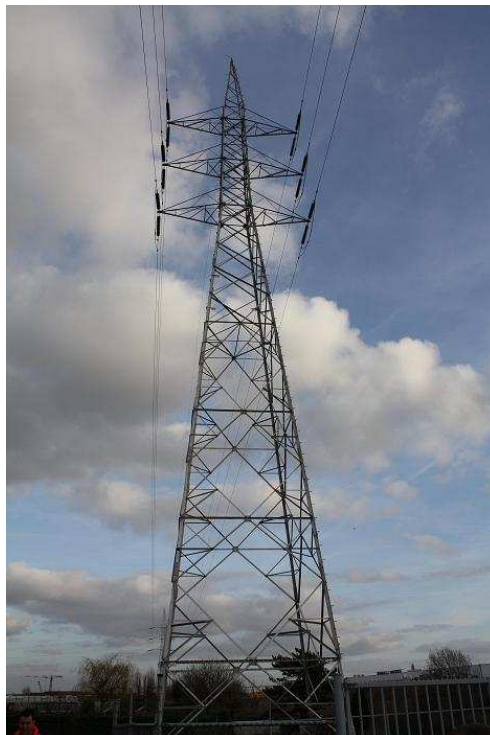
The cables were hanging from 2 poles (47 and 48), in a NW – SE direction.

The 150 kV high Voltage pole, next to where the helicopter landed (reference 48 of the 150.15-16 (EV204) line) has a height of 48.44 m (159 ft). The height of the ground cable at the point of contact with the helicopter would be slightly below that value.

The power distribution occurs by 2 series of 3 cables, left and right of the poles. That day, only the cables located on the south side were powered.

The distance between cables, as reported by Elia, the power distributor, is a minimum of 4.5m for the 150kV distribution cables.

Fortunately, the power line (3 cables) from the side of the helicopter was not powered at the time.
