Safety Investigation Report

ACCIDENT TO THE ROBINSON R44 II HELICOPTER REGISTERED OO-T** AT EBCF ON 01 OCTOBER 2011

Ref. AAIU-2011-24-EBCF-OO-T**
Issue date: 27 July 2012
Status: Final

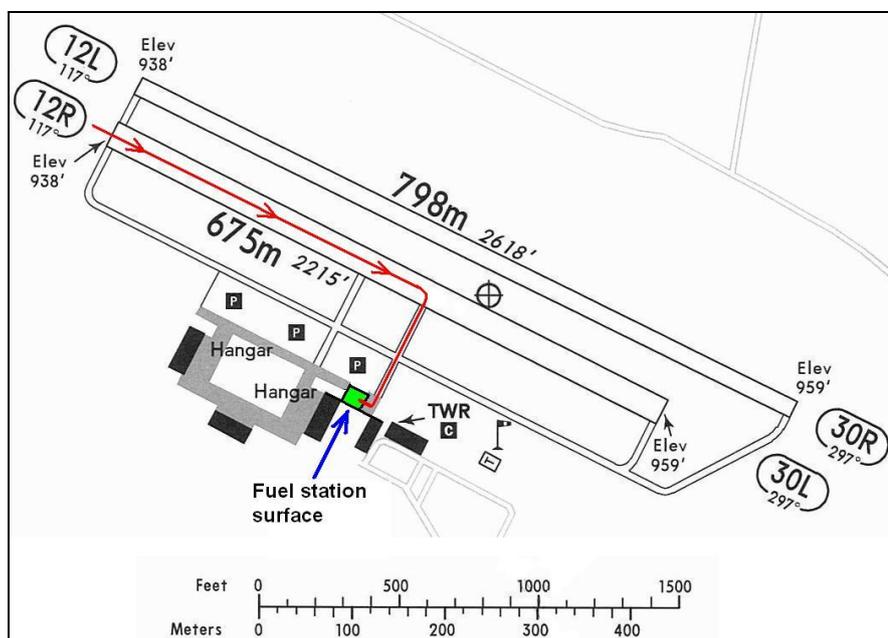
Figure 2: Flight path above EBCF airfield

A refueling installation is available for 100LL Avgas and for Jet Fuel A1. The length of the 100LL fuel pipe was measured as being around 13 meters while the ground cable was around 10,5 meters long.
