FINAL REPORT ON THE ACCIDENT TO THE EUROCOPTER AS355F1 REGISTERED OO-HSB IN ZUIENKERKE ON 23-NOV-2008

**Ref. AAIU-2008-19-Zuienkerke-HSB
Issue date: 30-04-2009
Status: FINAL**

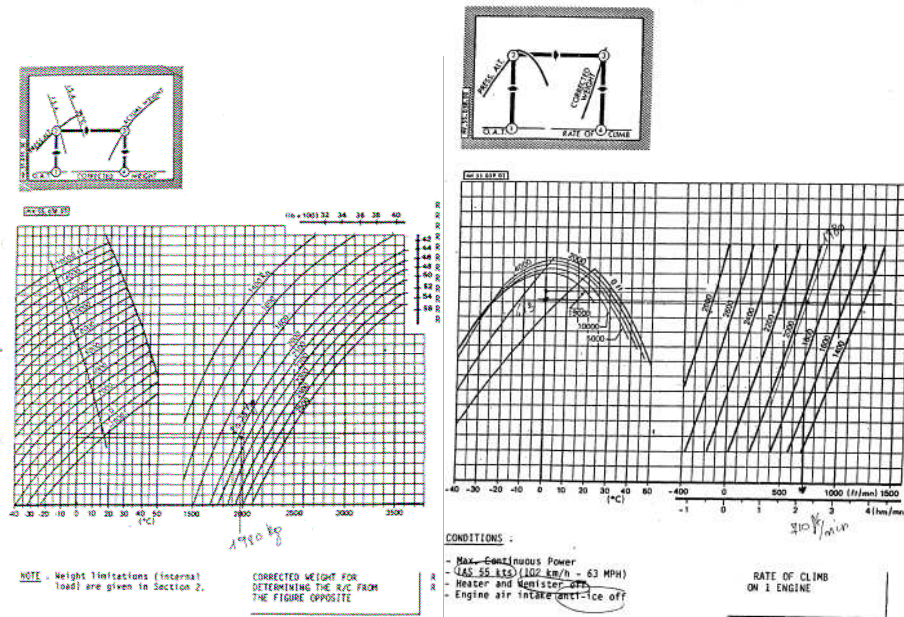
Figure 11: Rate of climb at optimal climbing speed (IAS) with OEI and no anti-icing, heater.

The flight characteristics of the AS355F1 given in figures 11, 12 show that, at optimal climbing speed (IAS²¹: 55KT; 102km/h), the rate of climb would decrease about 47% from 710 ft/min to 380ft/min by activating the anti-icing and heater.
